### **Failure of the fan levels 1 to 3 at Senator A and Monza**

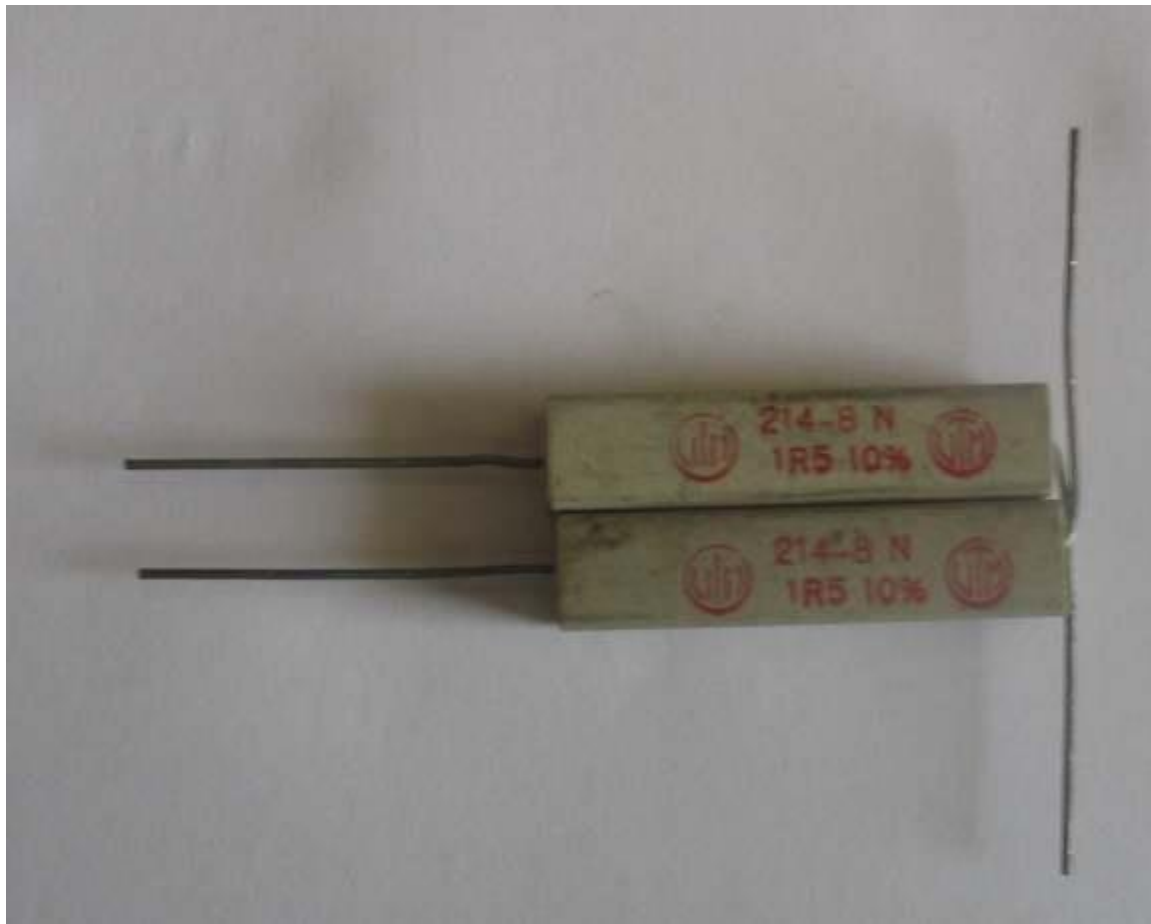
First we solder the two resistors together as in the following image.

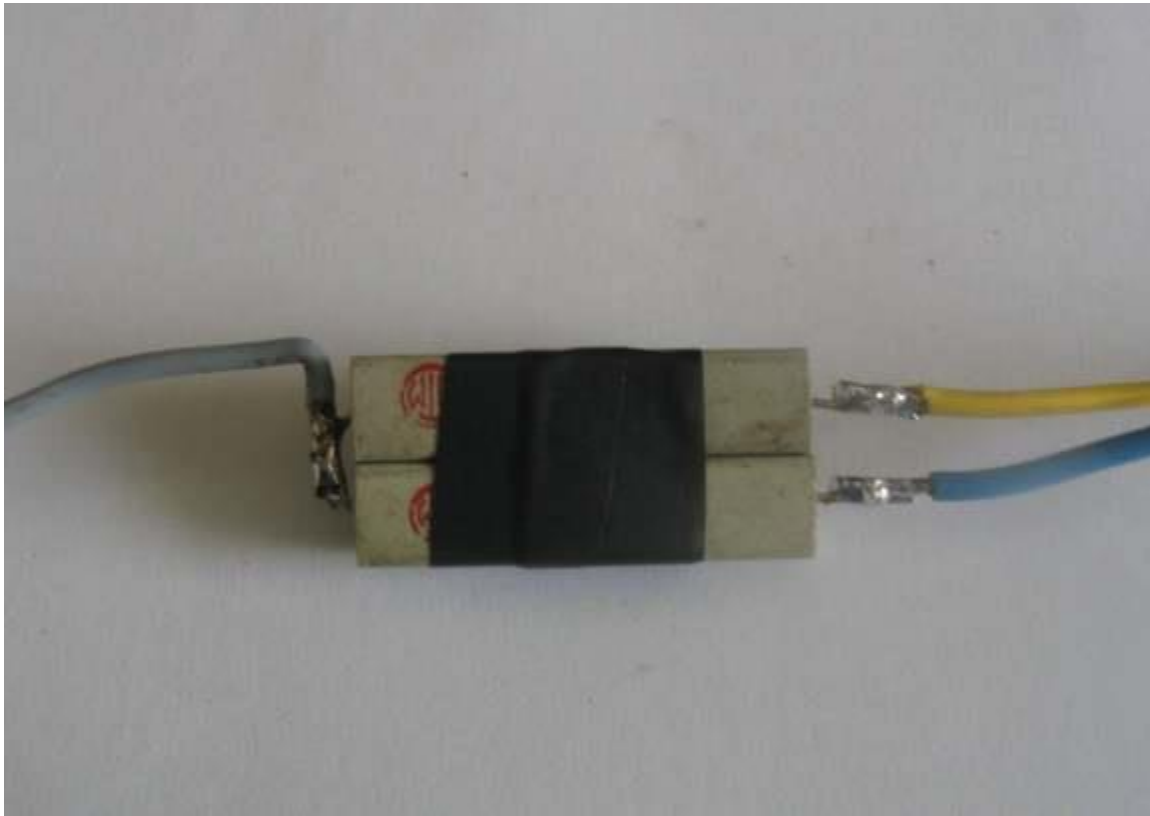
Now we solder the cable 3 gray, yellow and blue as the next image to be seen. For this, we can fix the two resistors temporarily with some tape together.

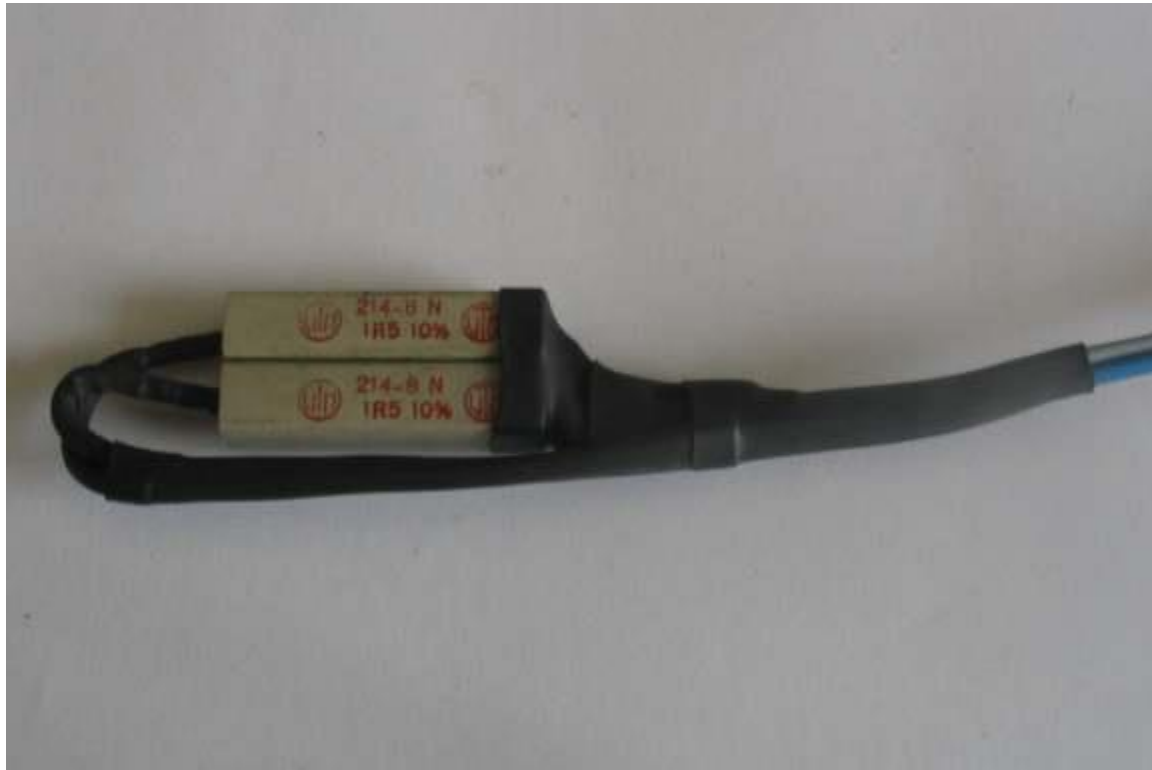
Now we slide approximately 5 cm long shrink tubes matching the diameter on the two individual cables, the side with the gray cable we provided prudent with large heat shrink tubing, which protrudes slightly through the resistors, but please only about 2-3 mm.

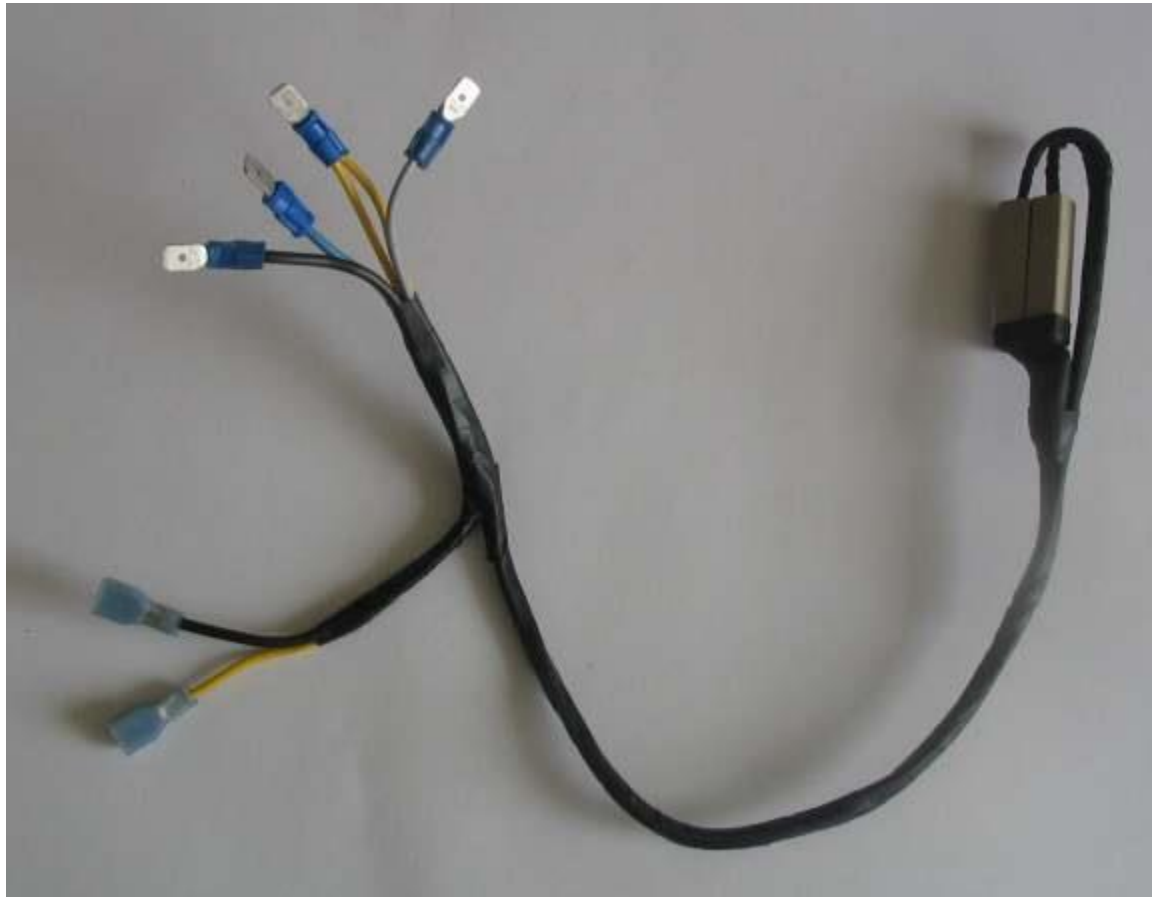
Now we cut the 3 cable ends after about 25 cm length evenly and squeeze each one PLUG-tongue, which at the yellow cable end we insert another yellow cable. This cable should have a length of about 12 cm. We're now finished in black cable to another bridge with a male tongue and a socket at the free end of the yellow cable, we also squeeze a STECKHÜLSE. Now we can wrap the individual cables carefully with electrical tape.

The whole thing looks like this:

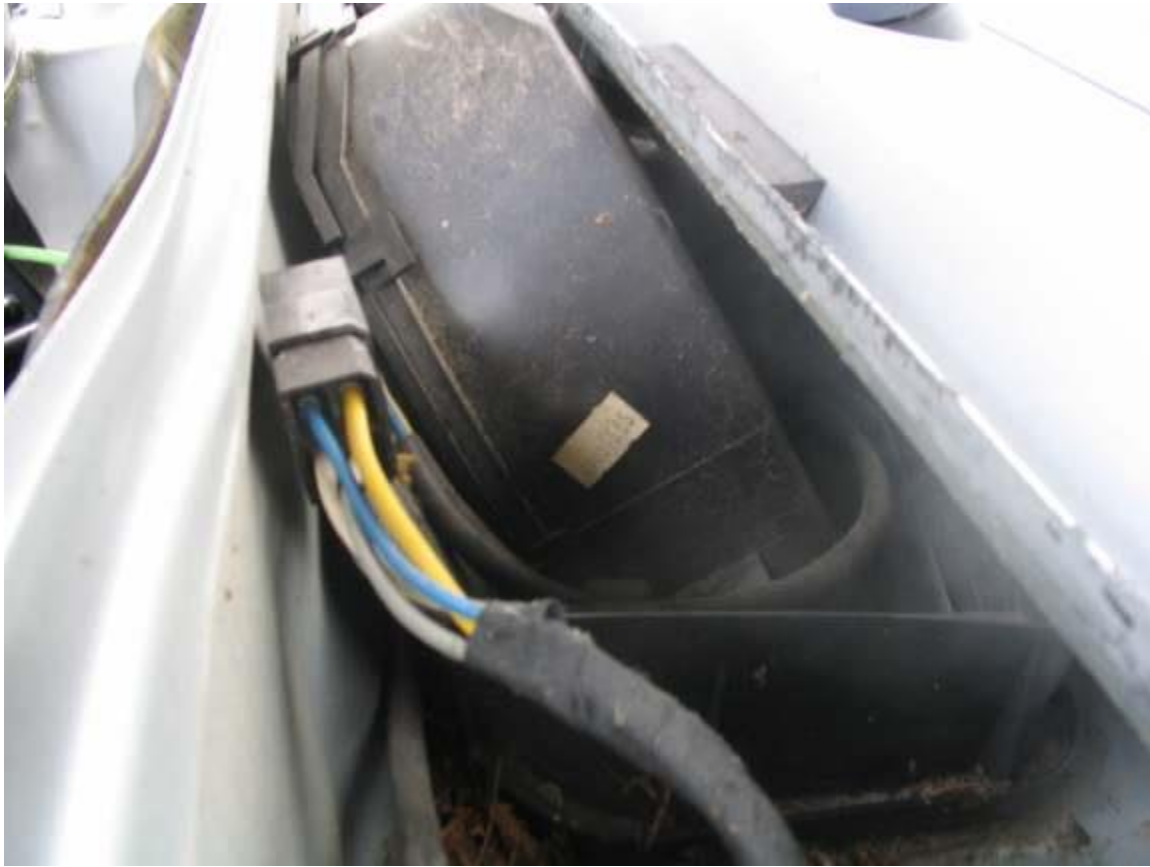
We deny in the engine compartment out the rubber seal between the bonnet and bulkhead cover and can then carefully remove the black plastic cover above the ventilation motor and the wiper linkage found. Here we find the plug-in connection of the fan motor and the main wiring harness.

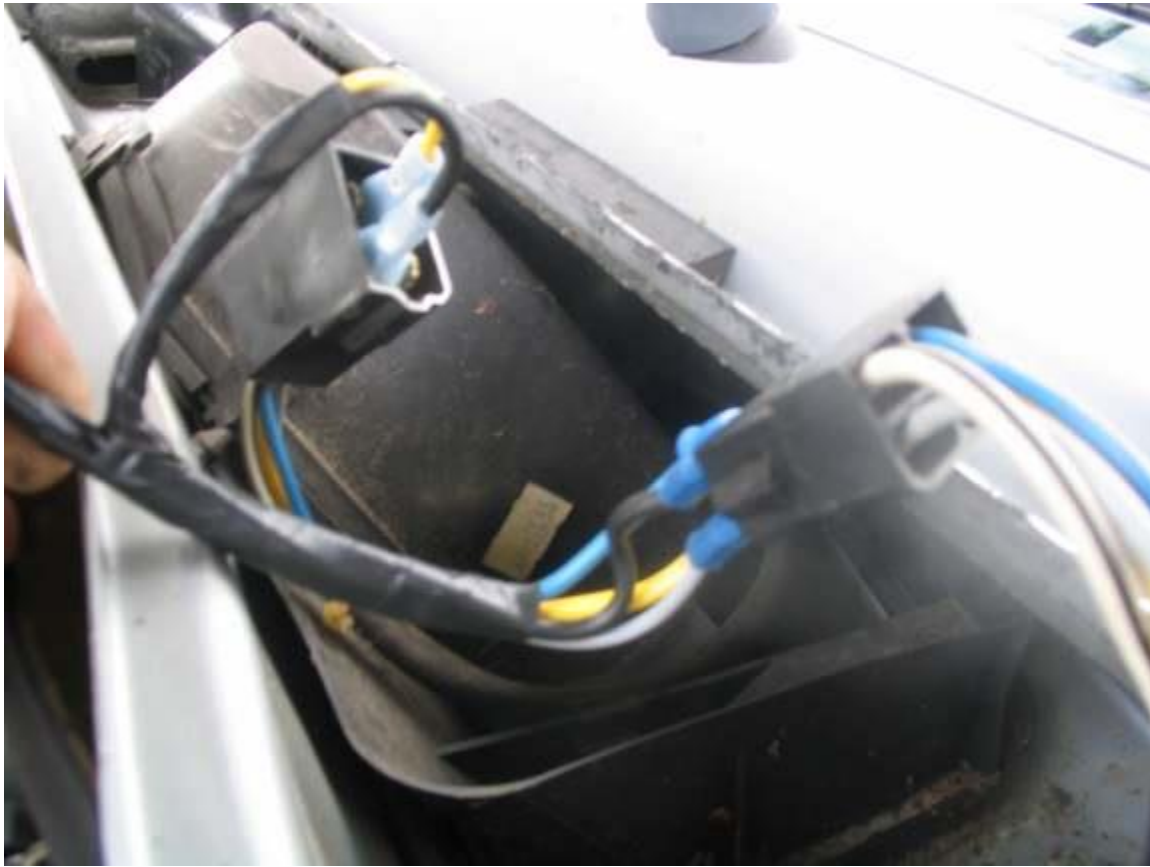
We pull apart the connector and then insert the plug blade in the corresponding color terminals on the side of the main wiring harness: gray on gray, yellow to yellow, blue on blue, black on white-black.

On the motor connection side we put each one STECKHÜLSE on Yellow on yellow, black on black and white.

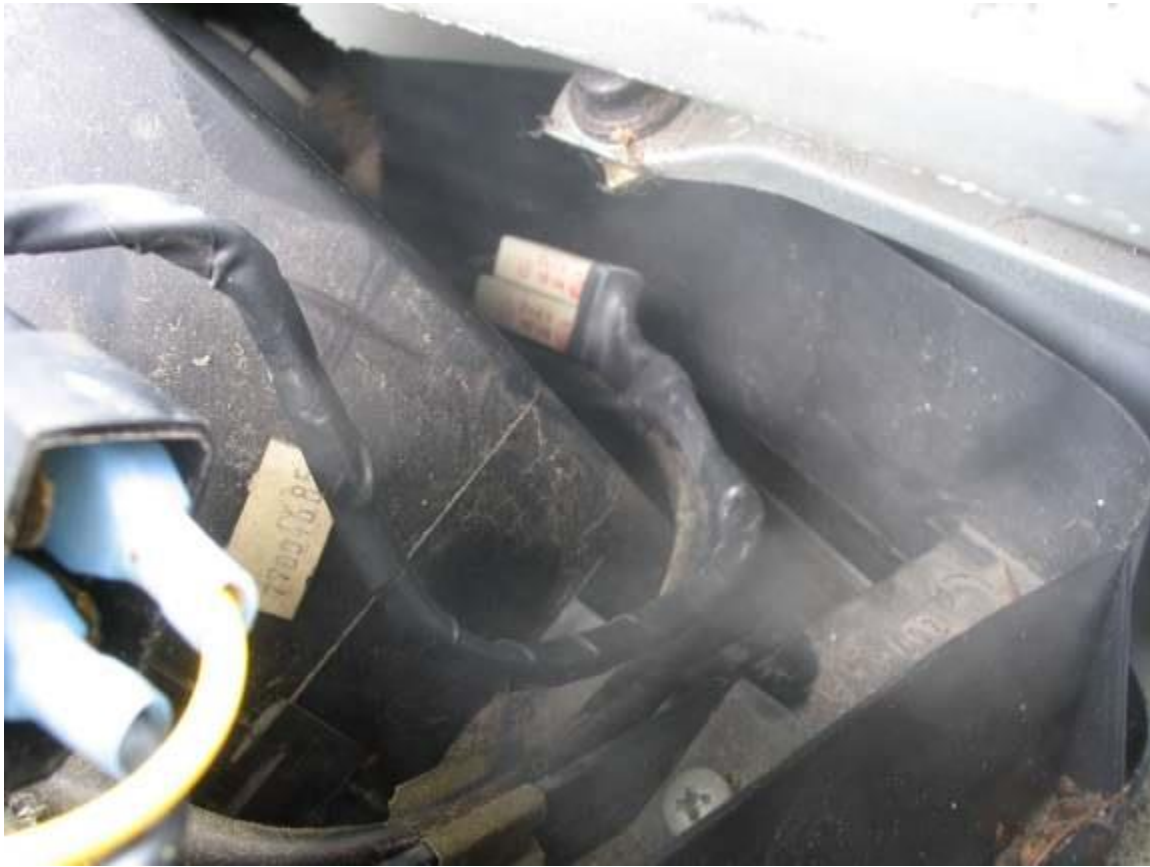
As the resistances in operation are warm / hot ... they have to be cooled. We can accomplish this in 2 ways:

As factory in the air flow of the intake of the fan, or with some additional case cooling. Here first the positioning of the air stream, these should be carried out carefully, the equivalent resistance combination can be well placed and secured with cable ties.

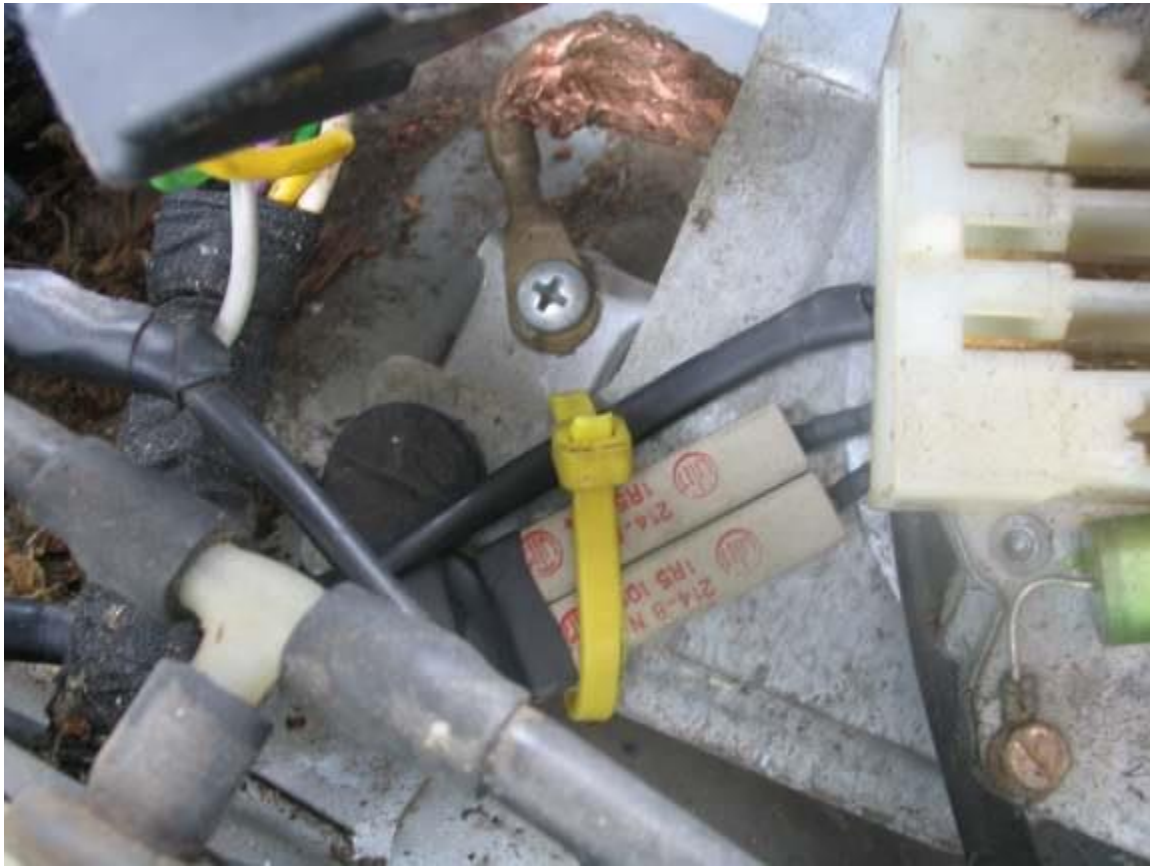
Also offers the following site for a passive cooling housing, please attach but with several cable ties good quality.
