# WIRING DIAGRAMS

Figure 1J-1 Windshield Wiper and Horn - Opel 1900 - Manta

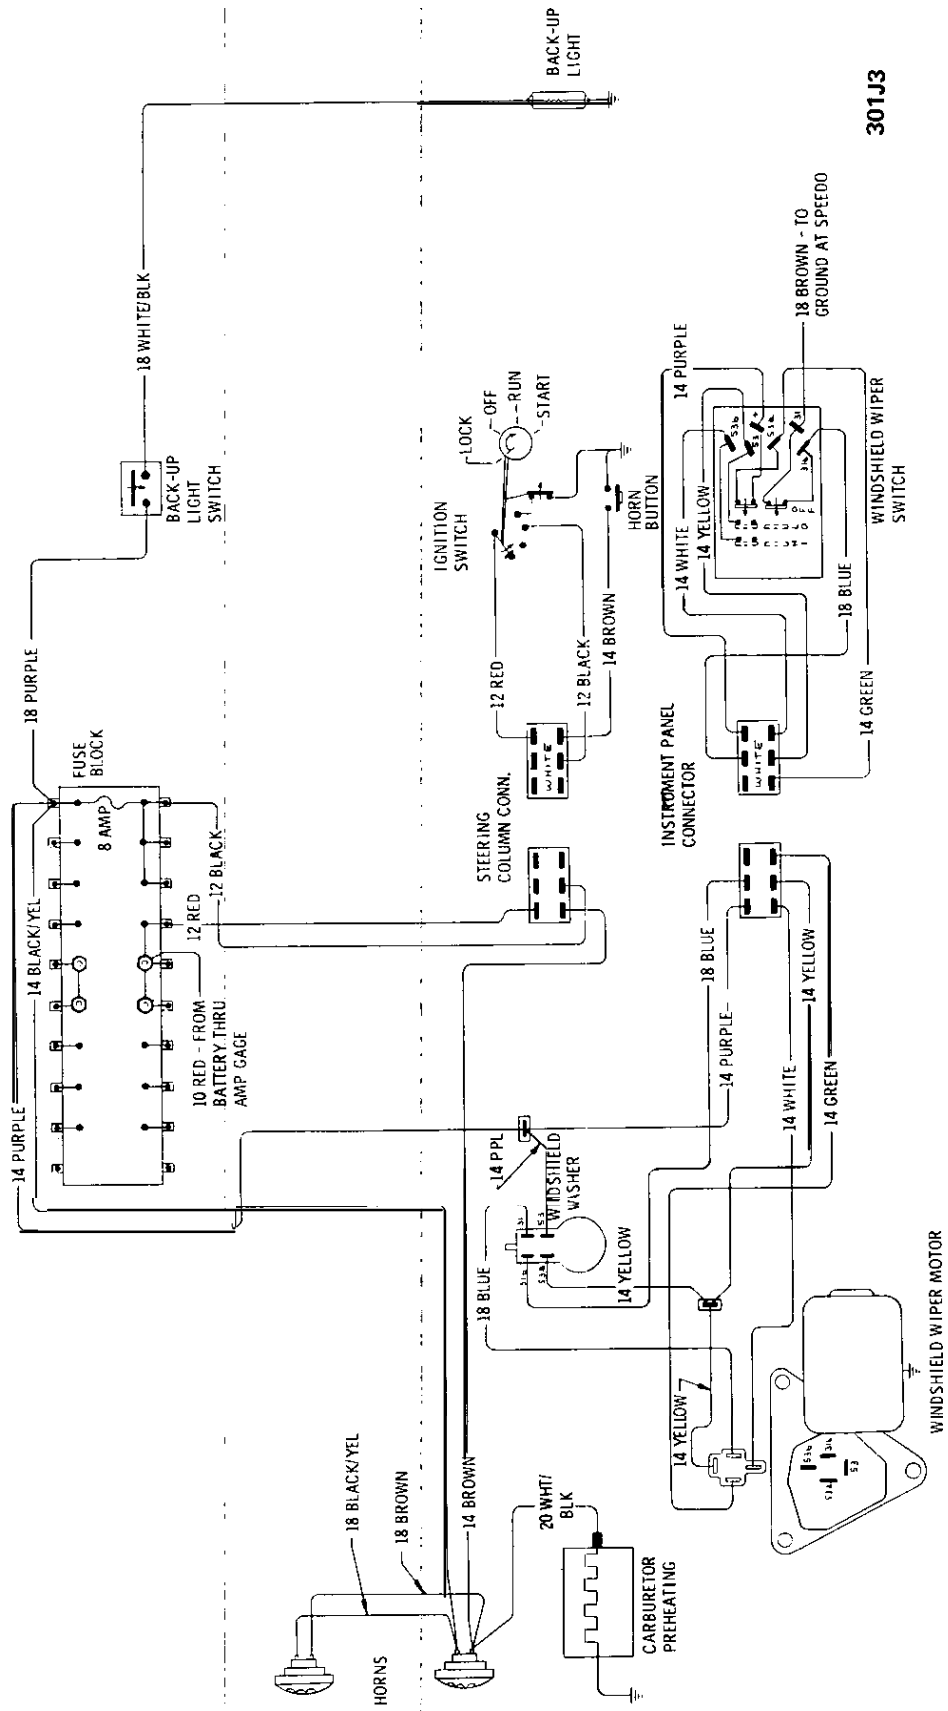
301J3

Figure 1J-3 Windshield Wiper and Horn - GT

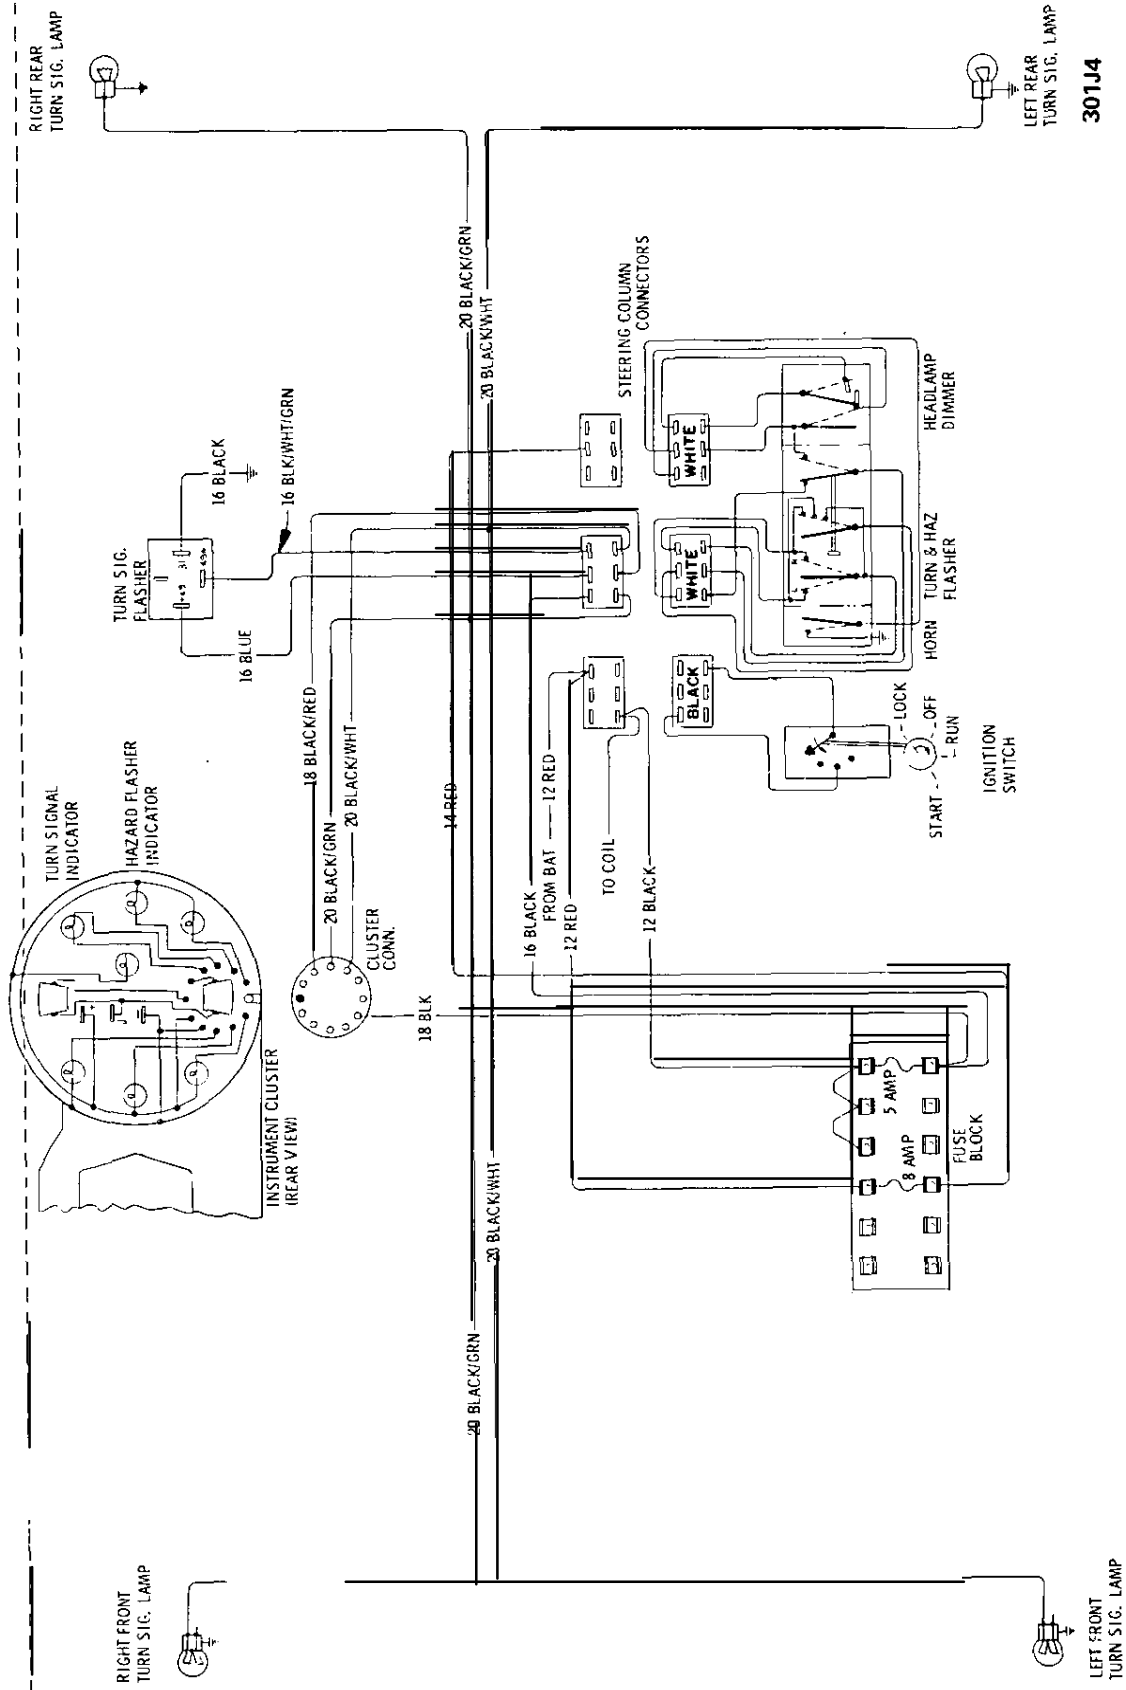
301J4

Figure 1 J-4 Turn Signal and Hazard Flasher . Opel 1900 . Manta

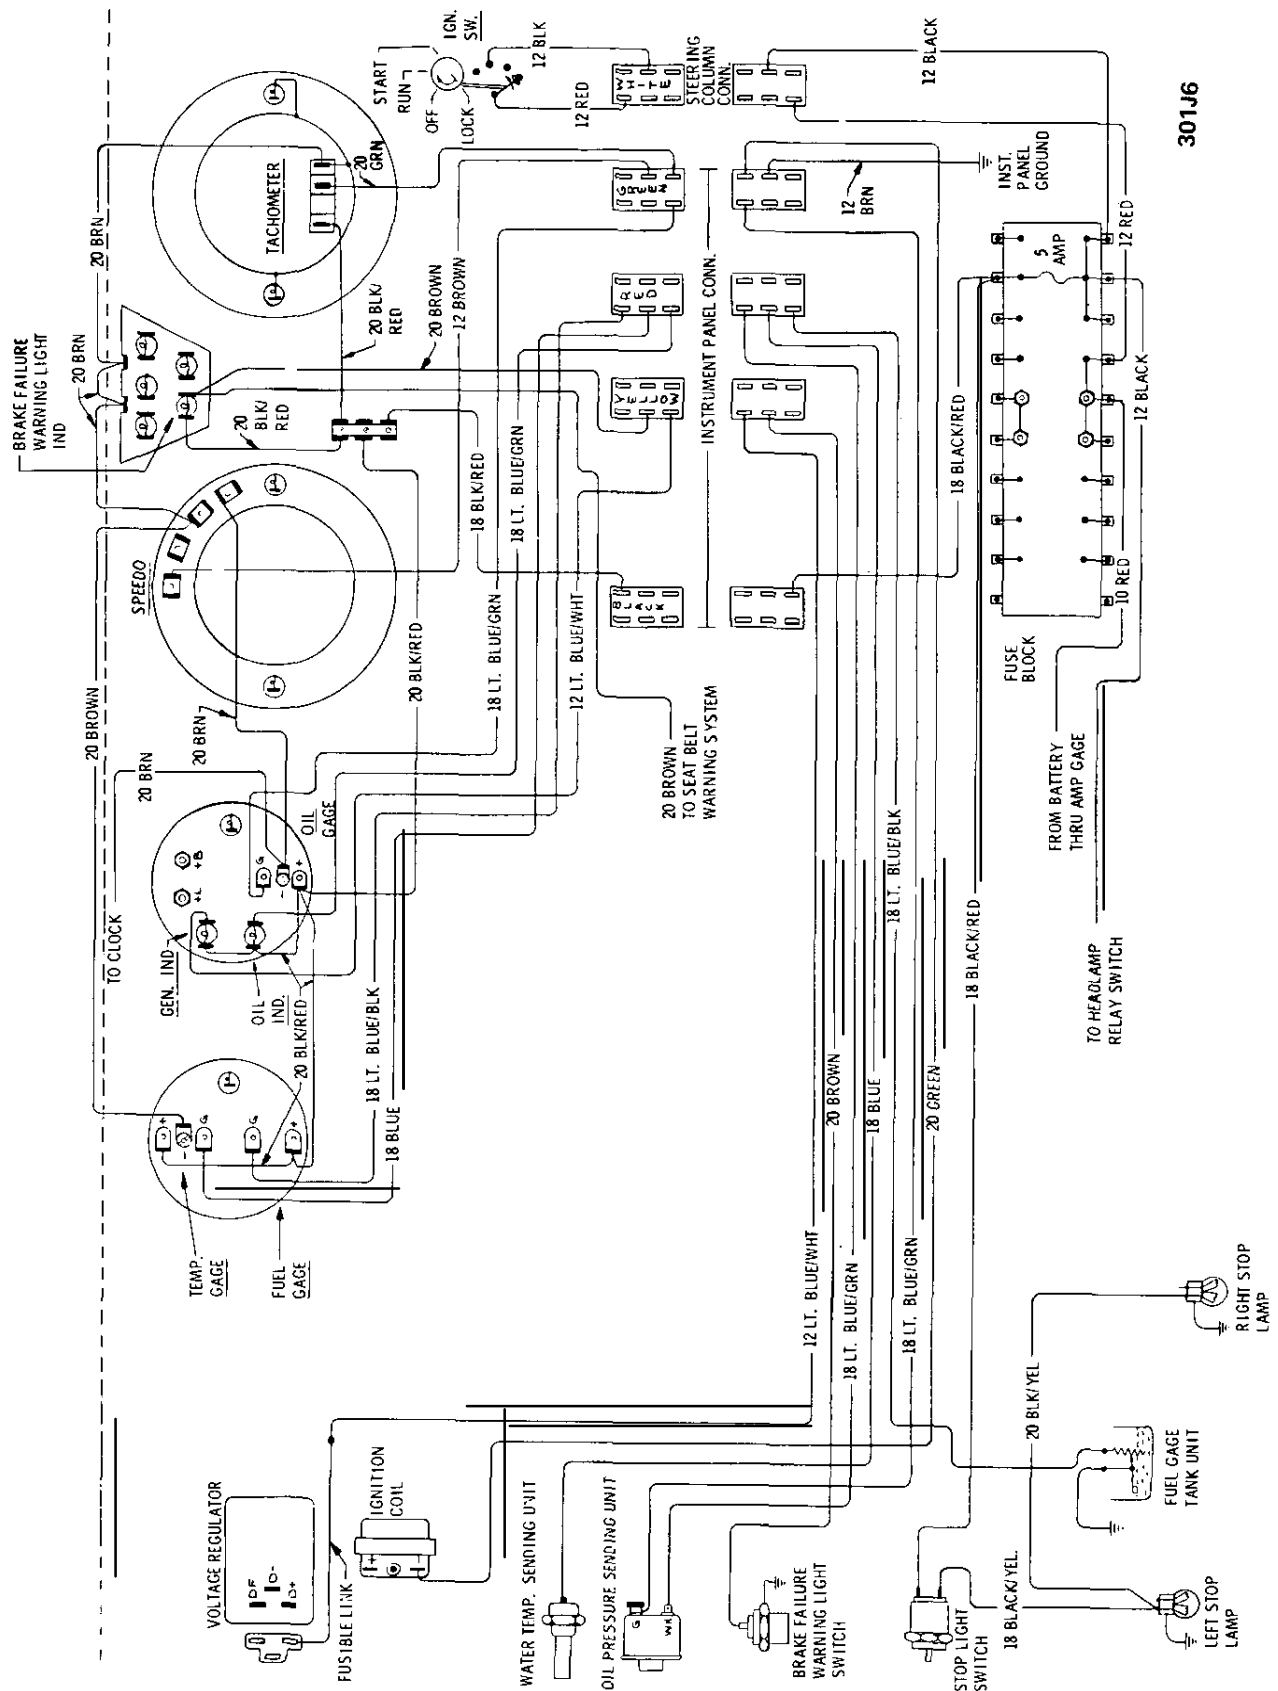
301J6

Figure 1J-6 Oil, Fuel, Temp. Tach, Stop and Brake Warning Light - GT

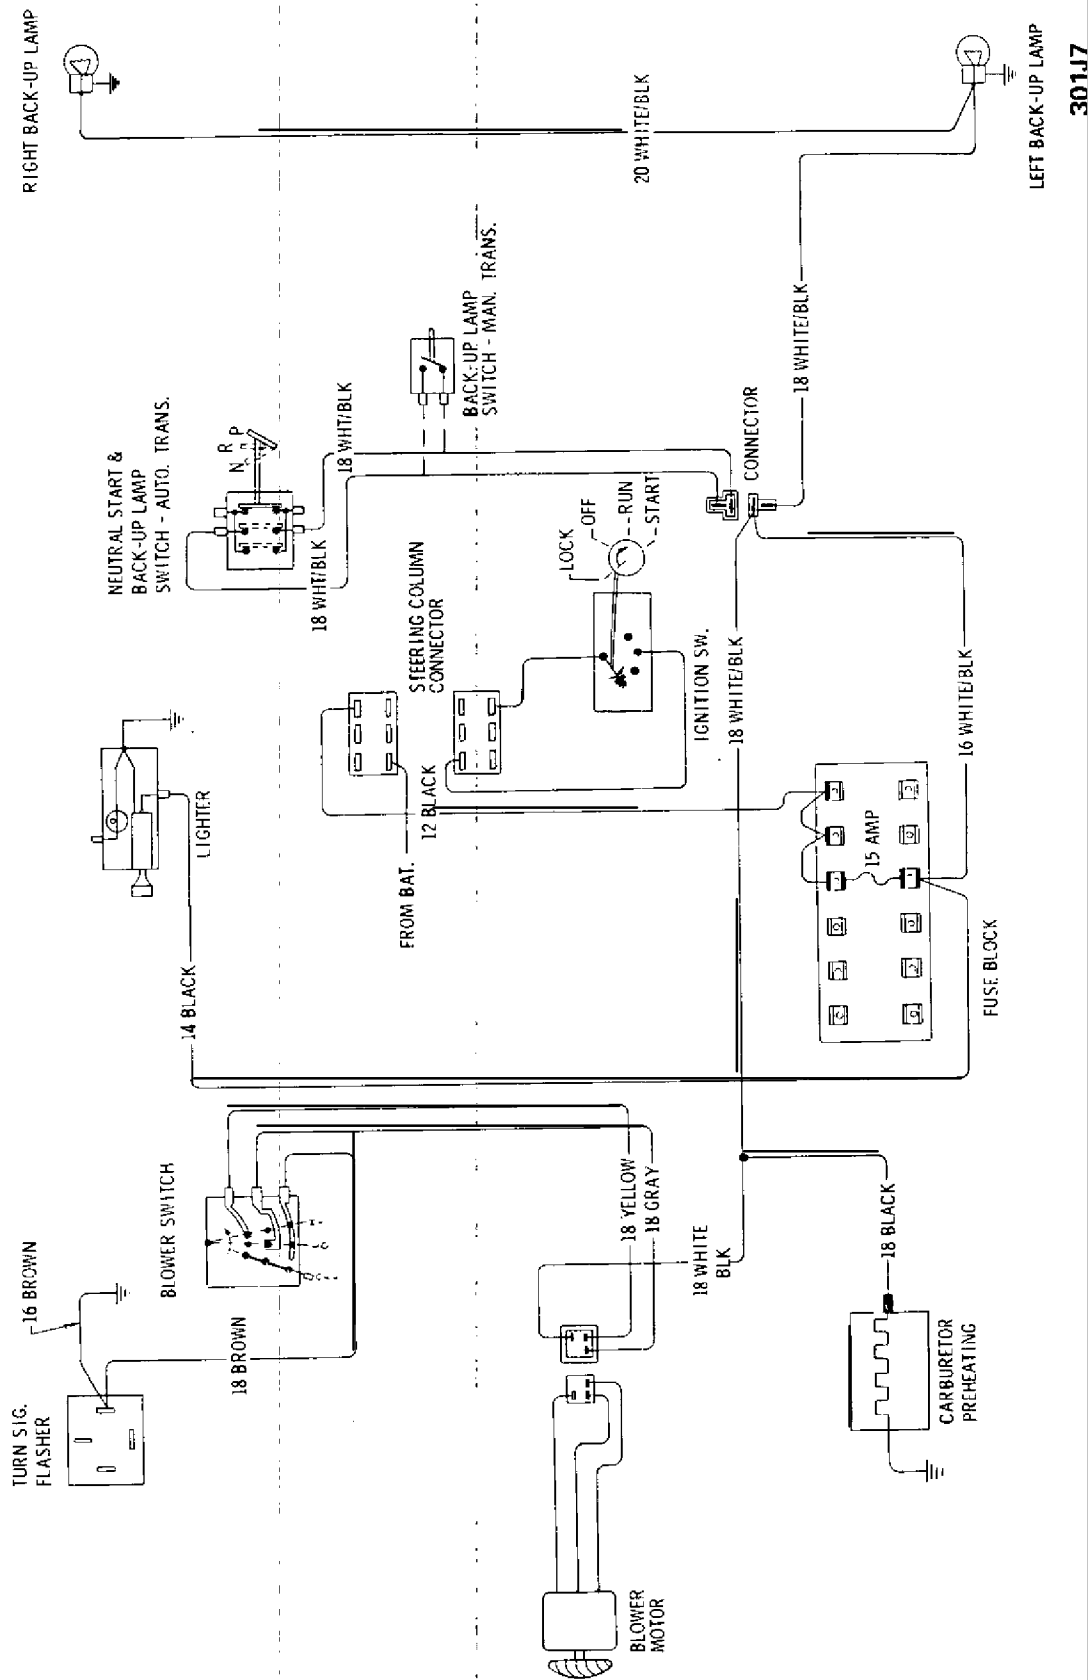
Figure 1J-7 Blower, Lighter and Backup Lights - Opel 1900 - Manta

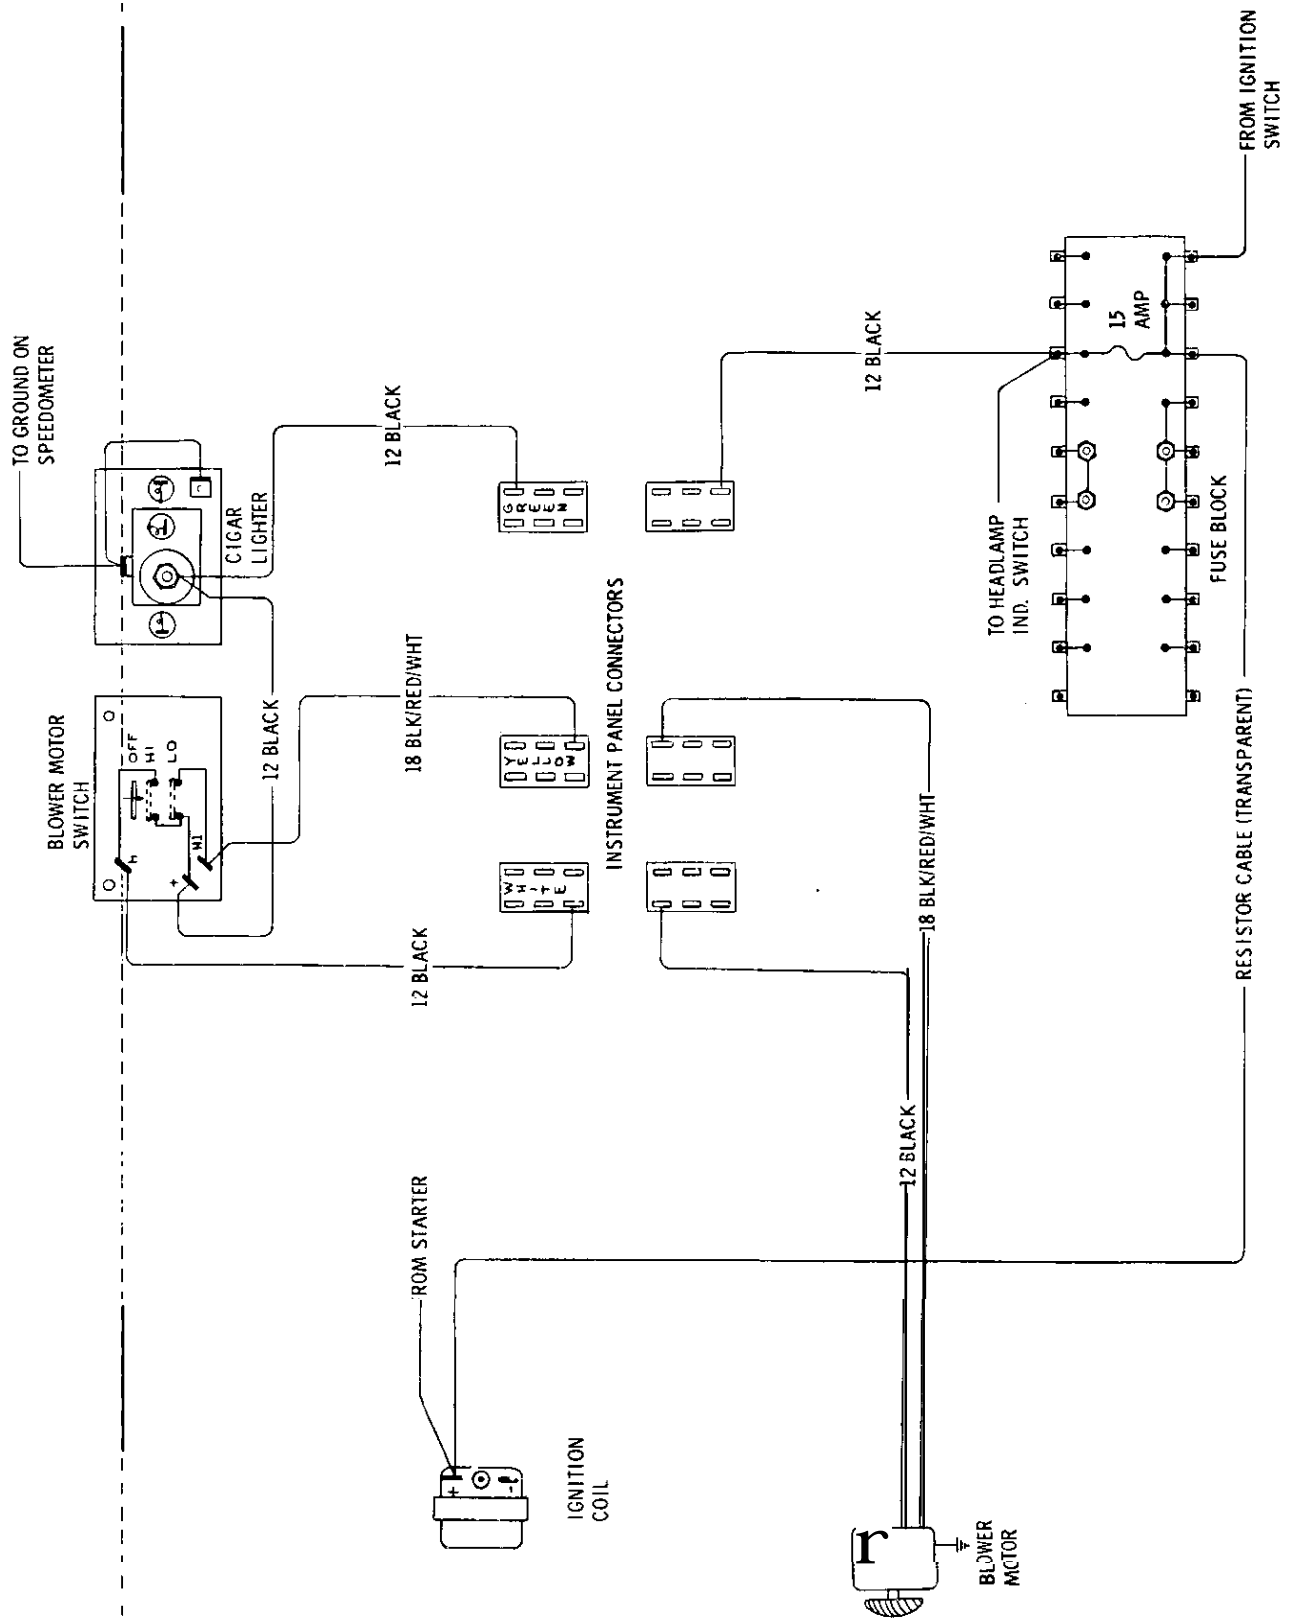
301J8

Figure 1 J-8 Blower and Lighter - GT

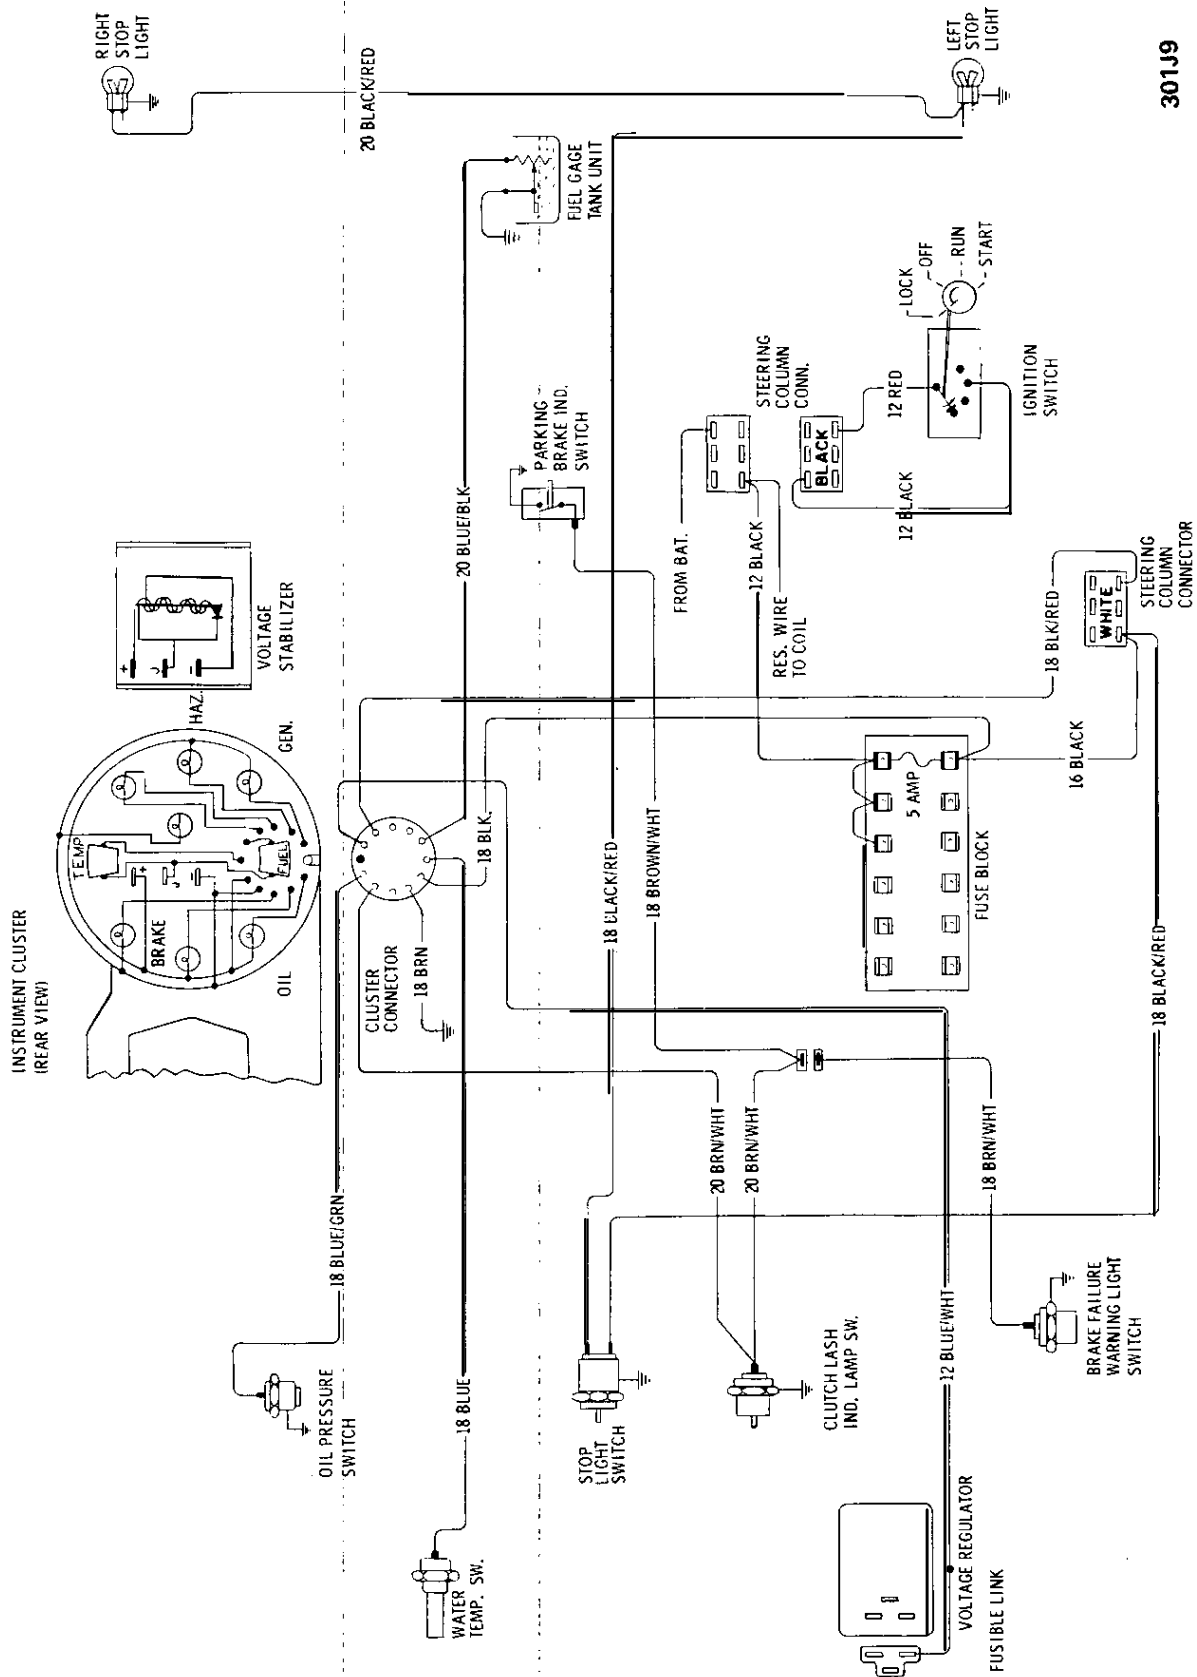
301J9

Figure 1J-9 Indicator Lights and Gauges • Opel 1900 Manta

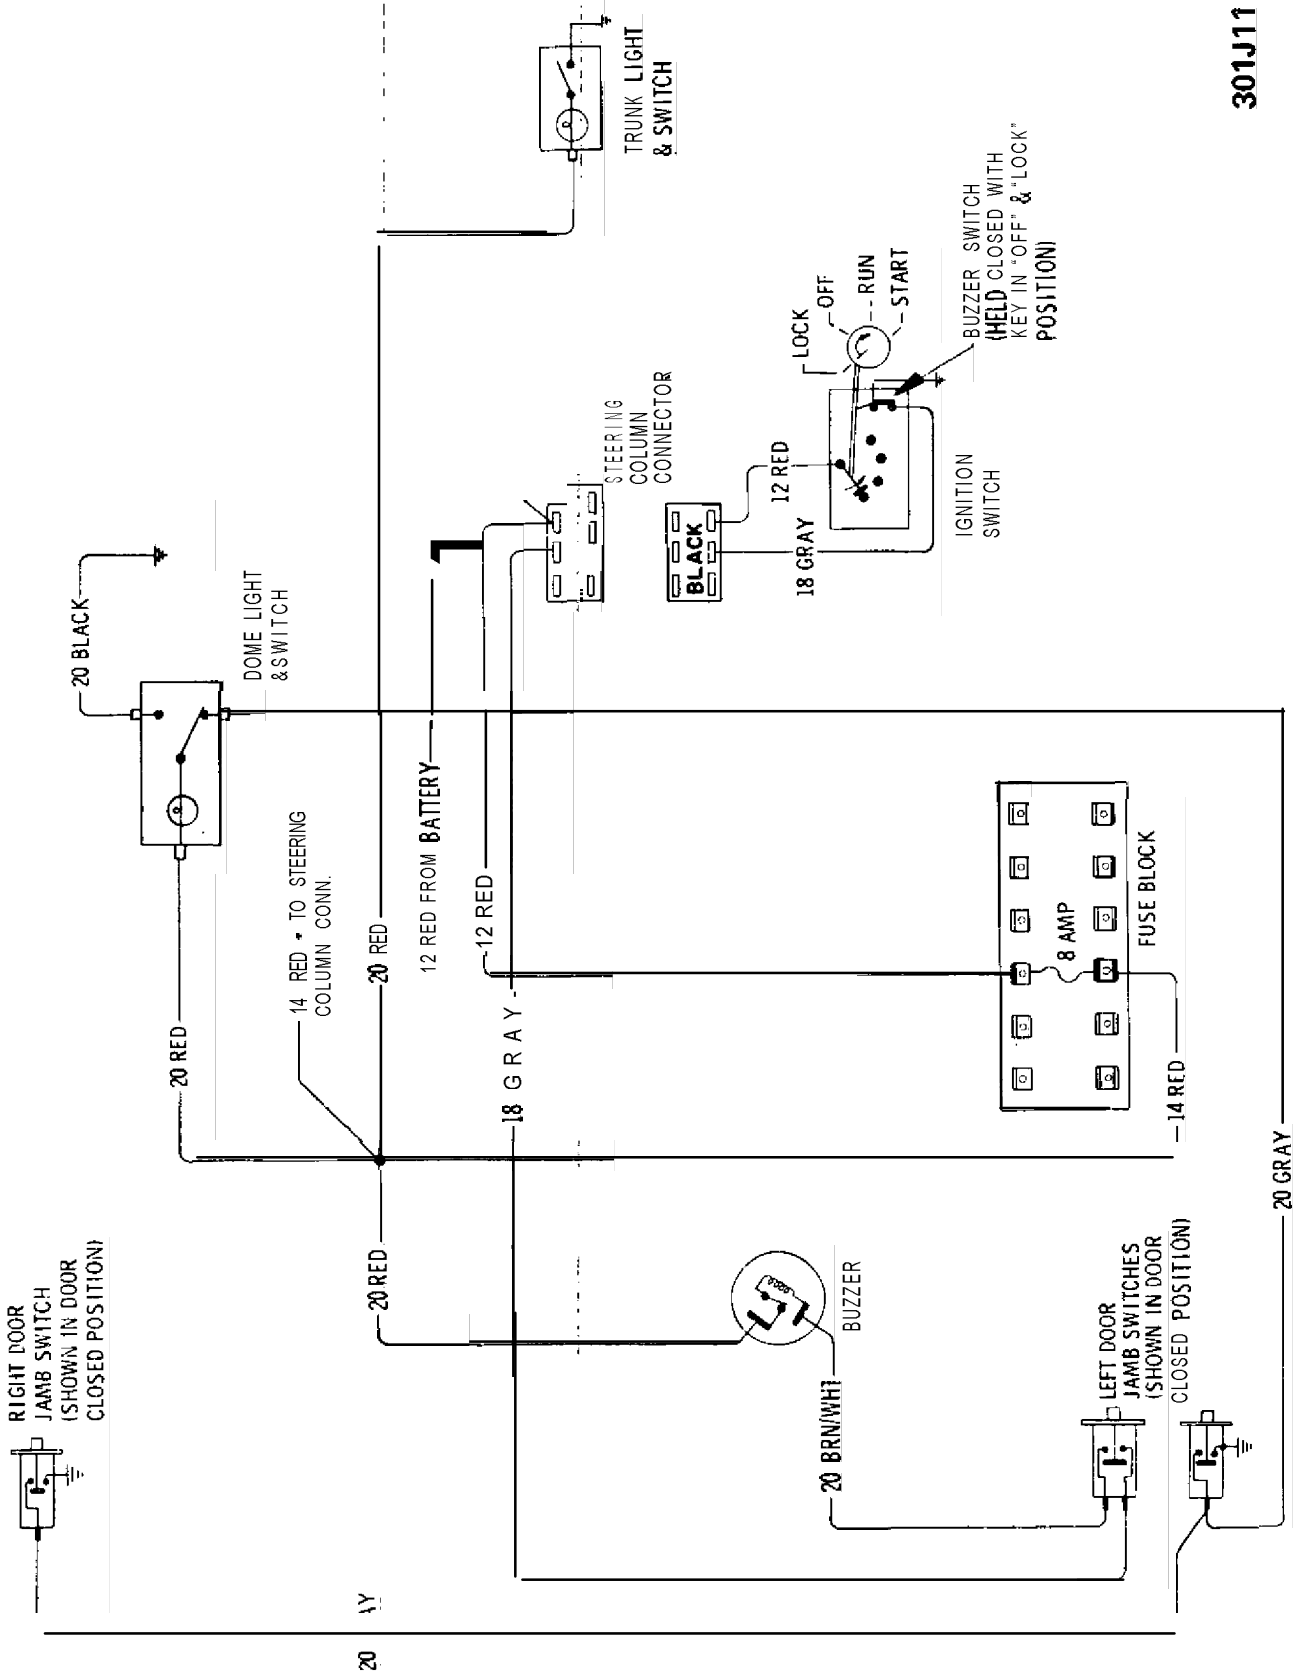
301J11

Figure 1J-11 Dome Light and Buzzer - Opel 1900 - Manta

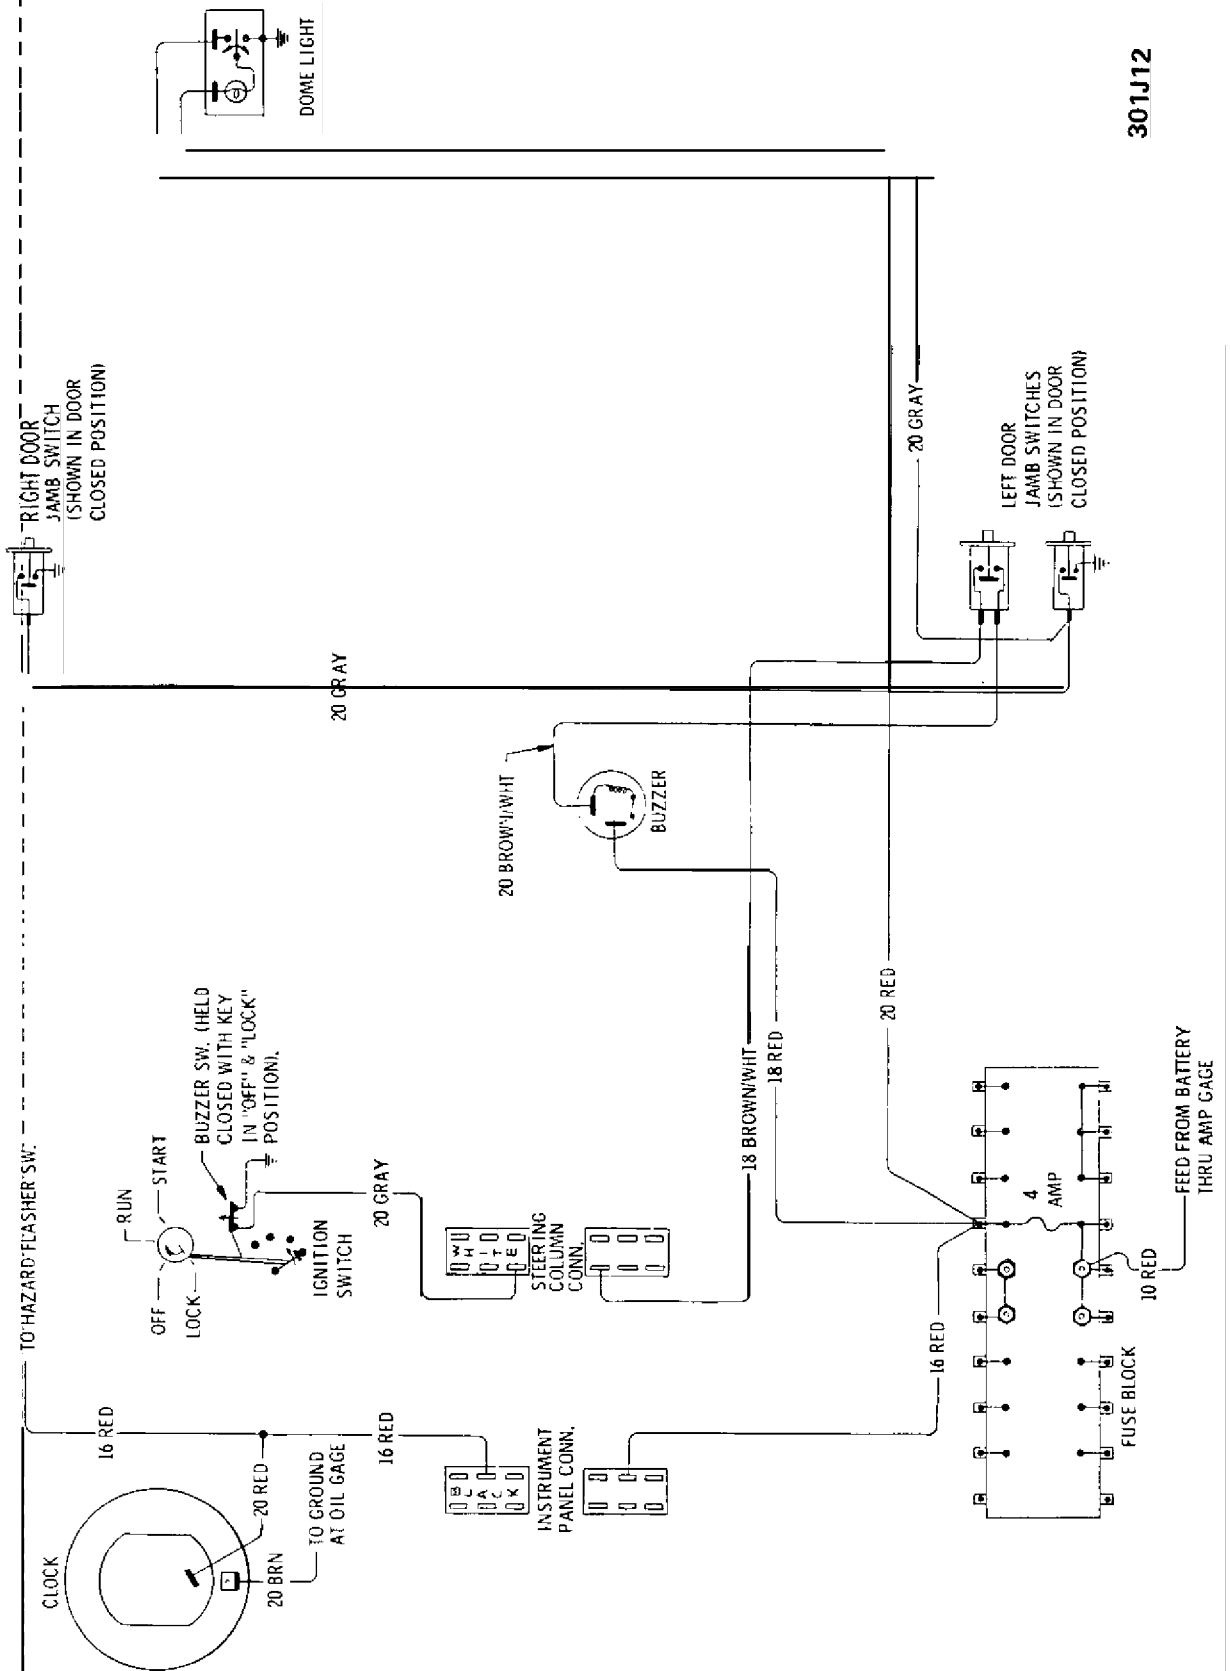
301J12

Figure 1J-12 Dome Light, Clock and Buzzer - GT

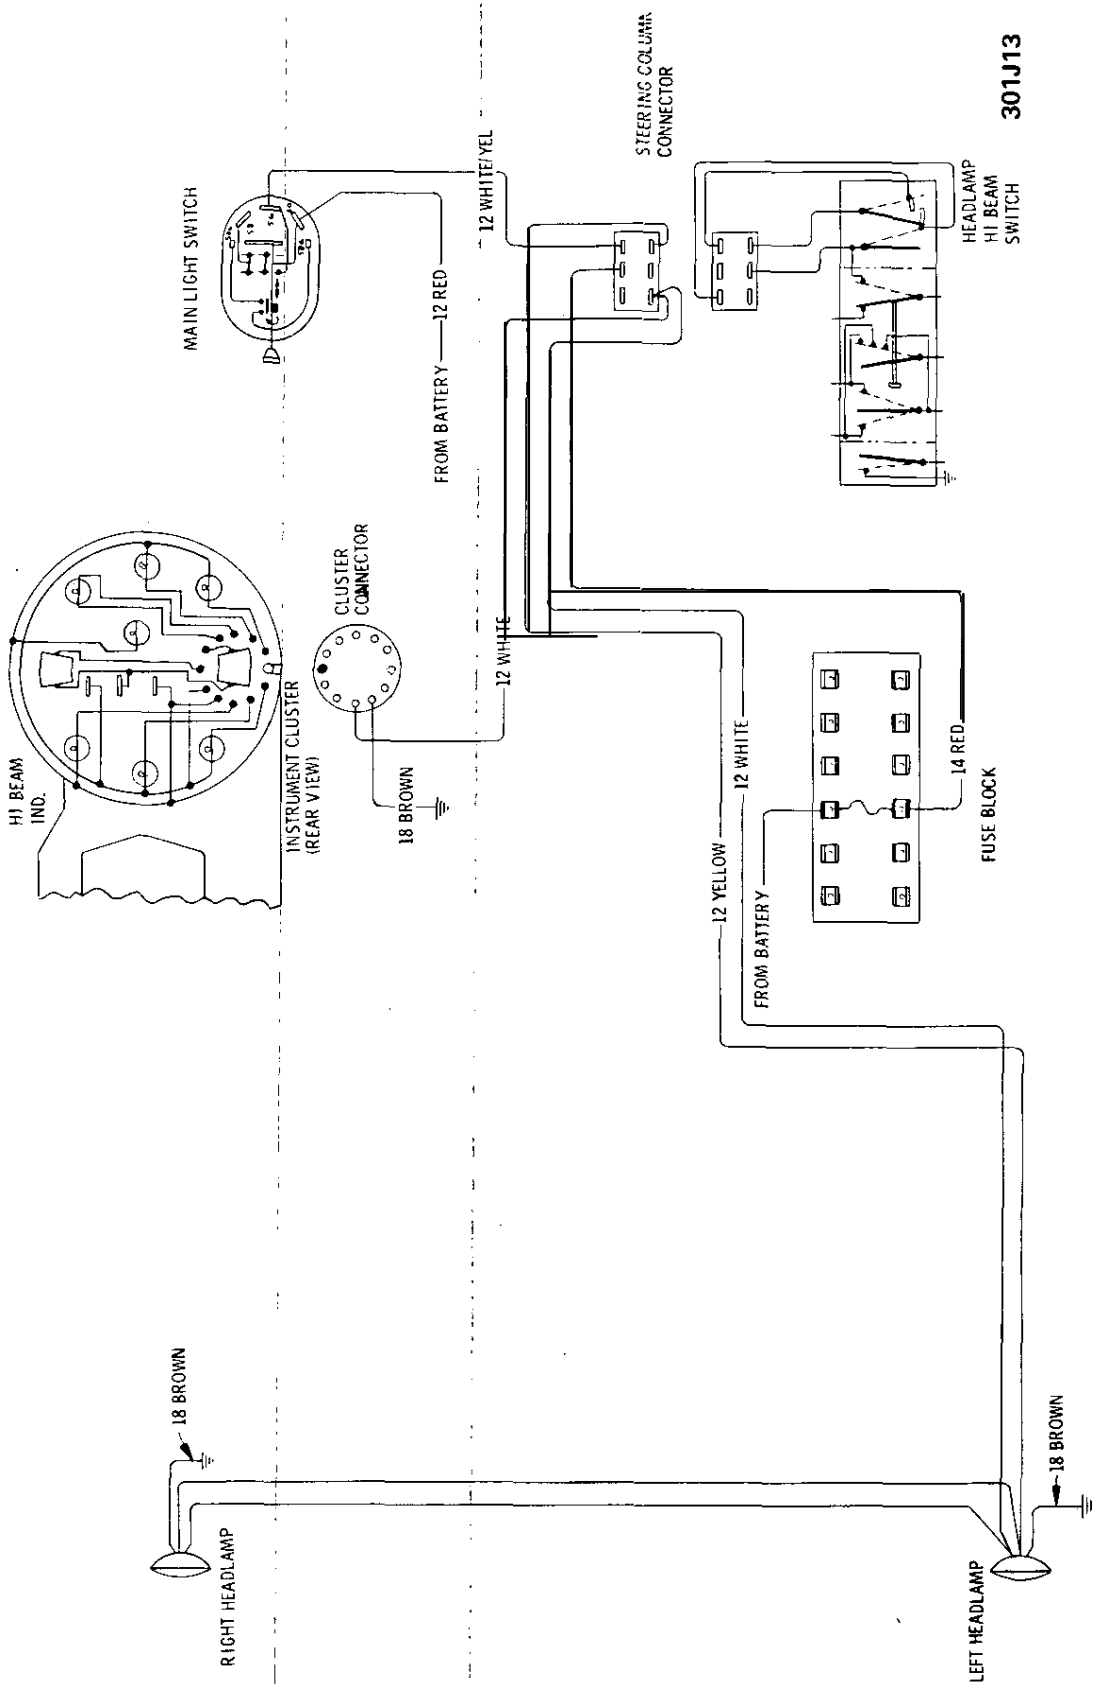
301J13

Figure 1 J-I 3; Headlamps • Opel 1900

INSTRUMENT-CLUSTER  
(REAR VIEW)

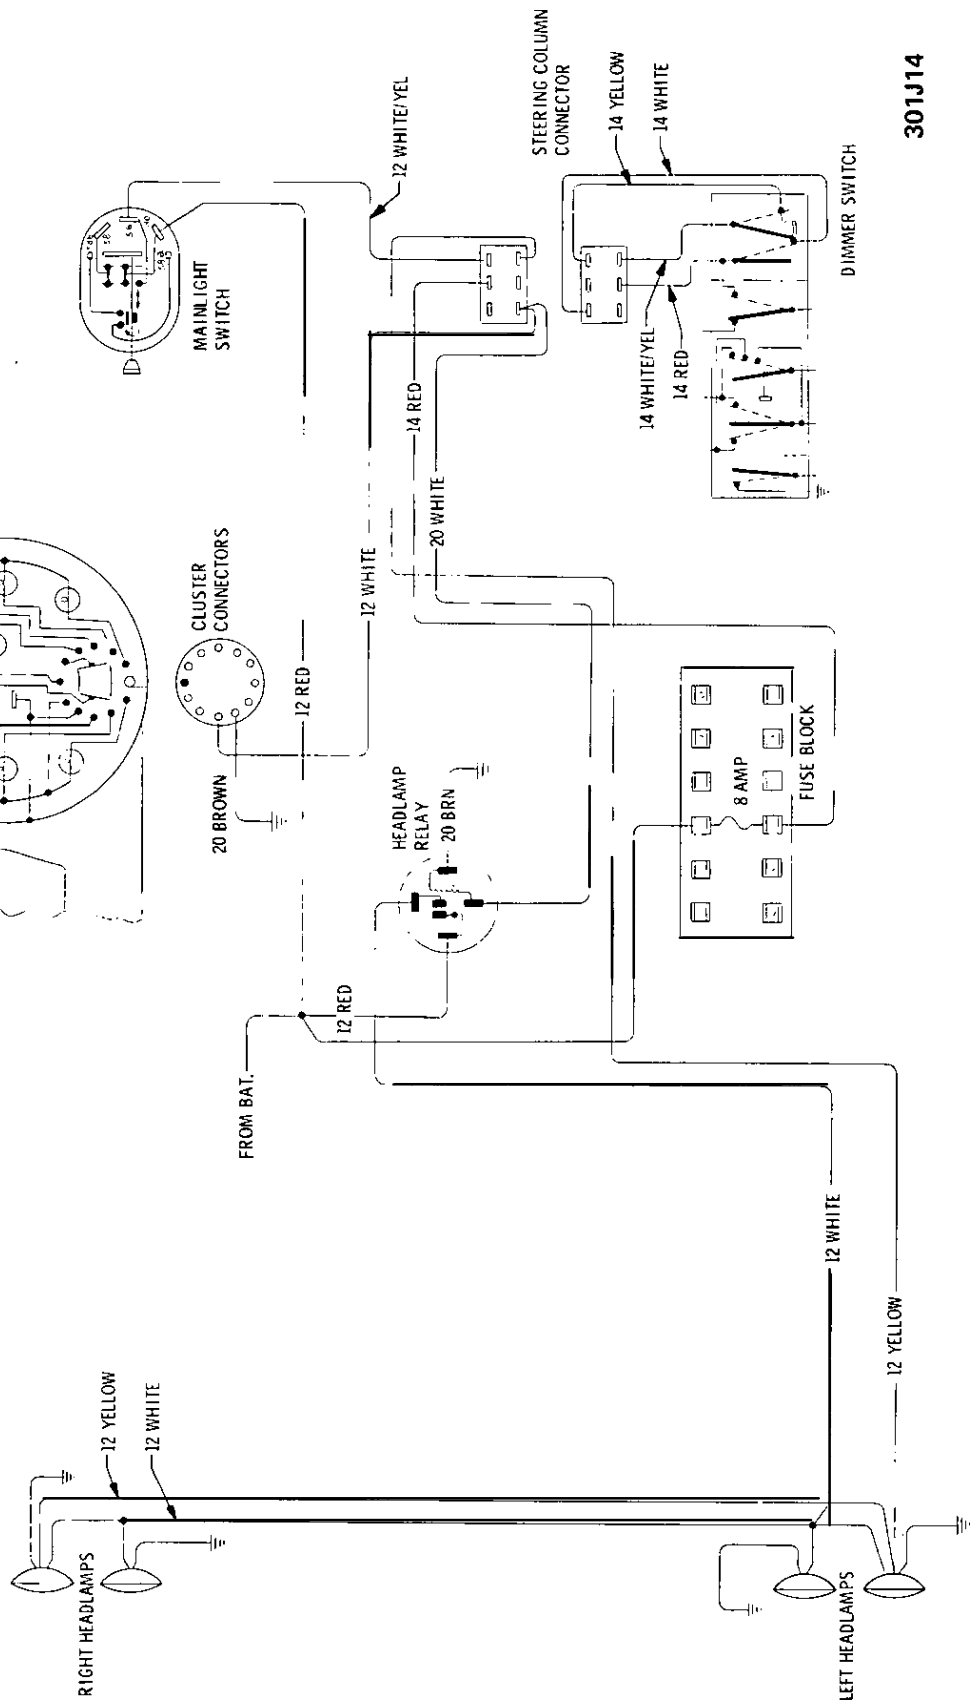
301J14

Figure 1J-14 Headlamps Manta

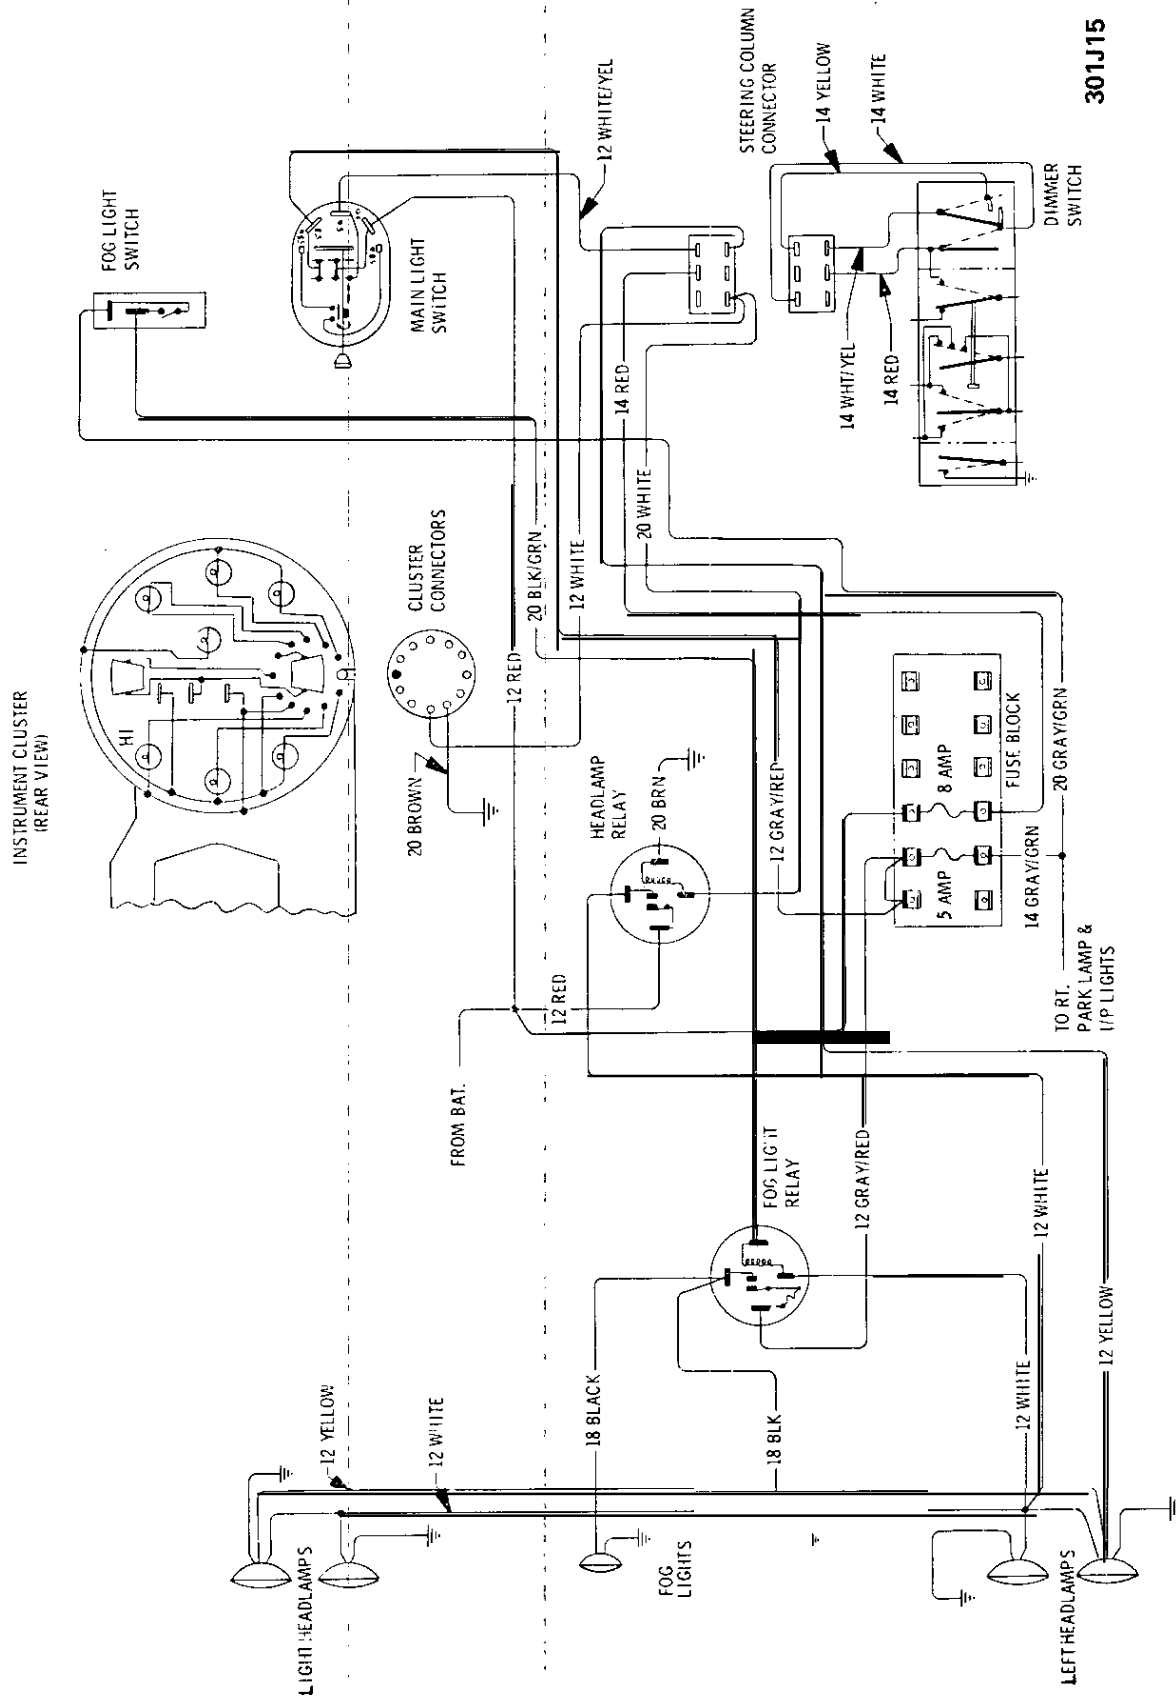
301J15

Figure 1J-15 Headlamp and Fog Lights - Rallye
