# WIRING DIAGRAMS

Figure 1J-1 Windshield Wiper and Horn - Opel 1900 - Manta

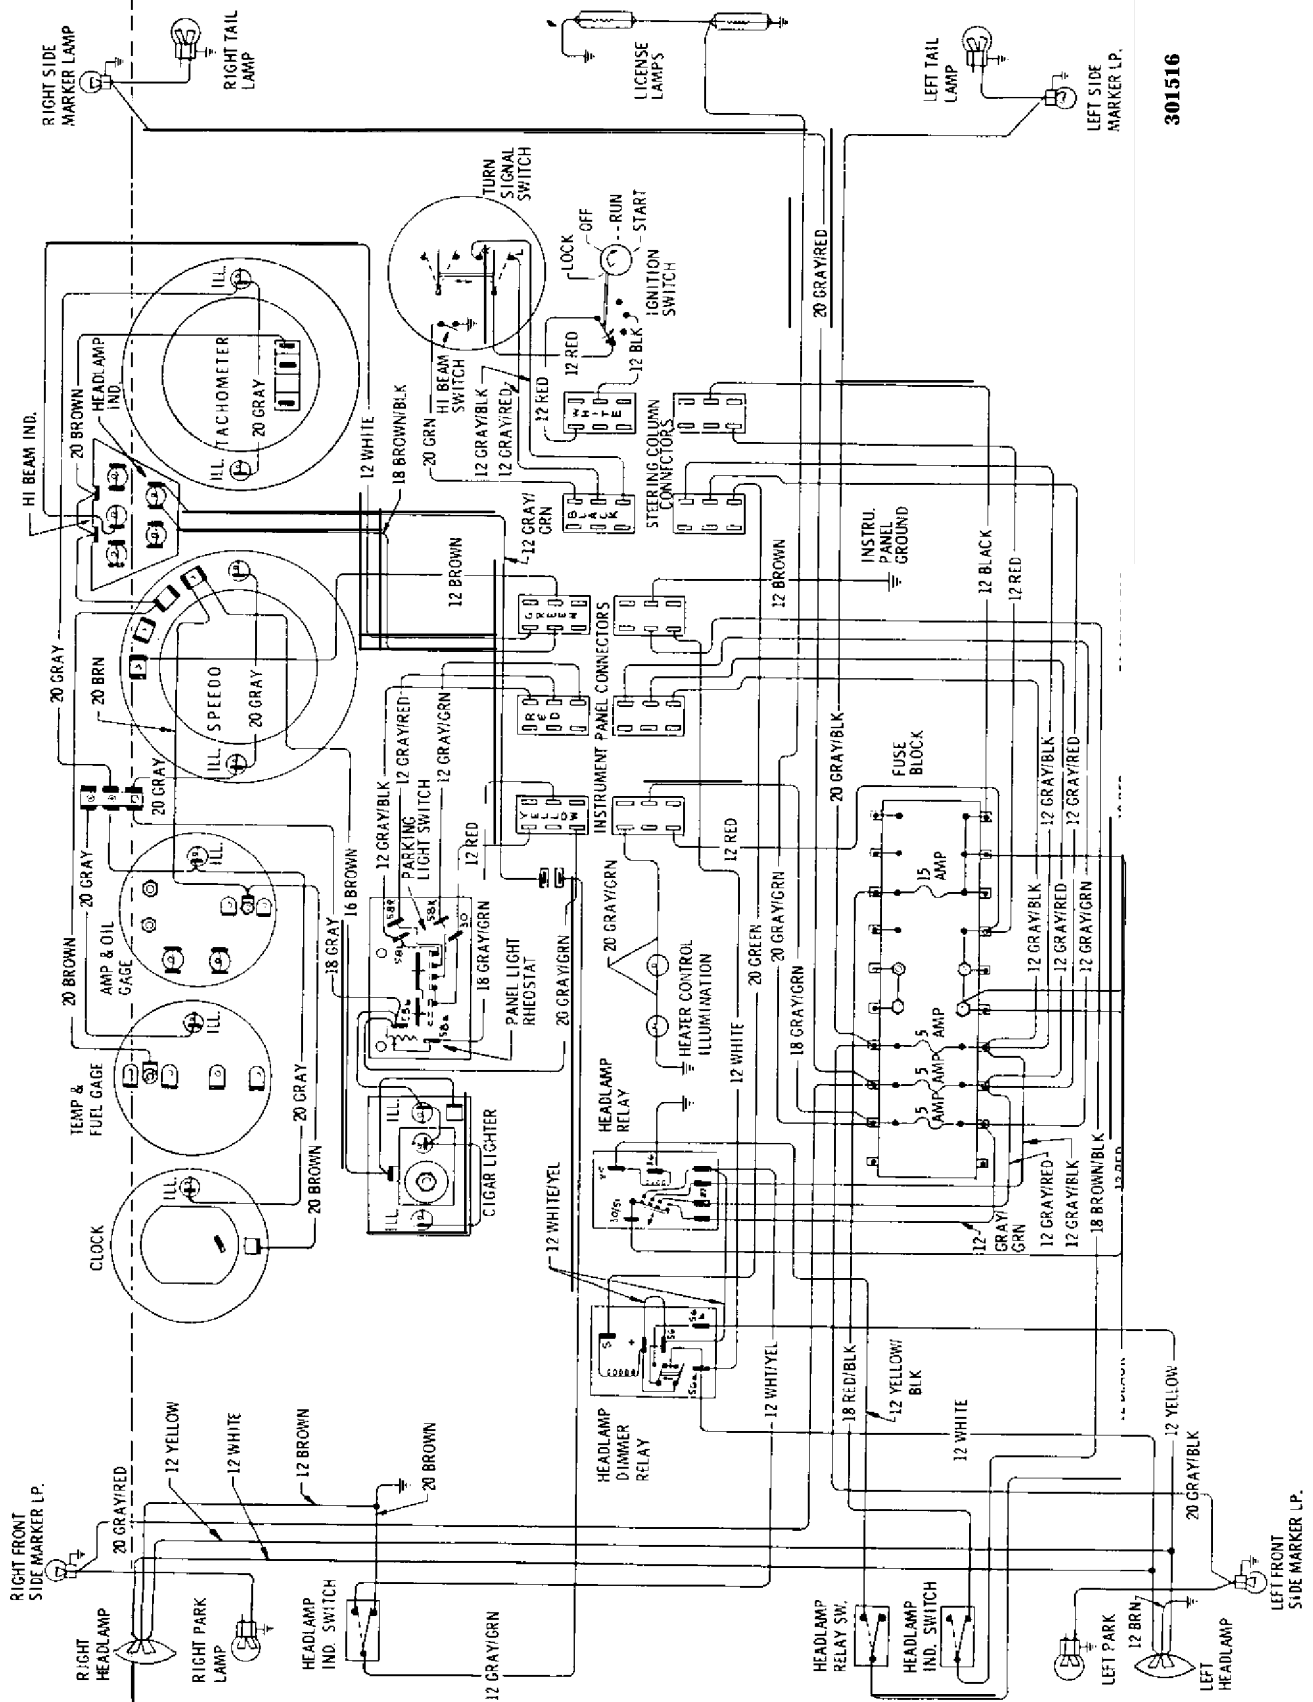
301516

Figure 1J-16 Headlamps, Parking, Tail and Instrument Panel Lighting - GT

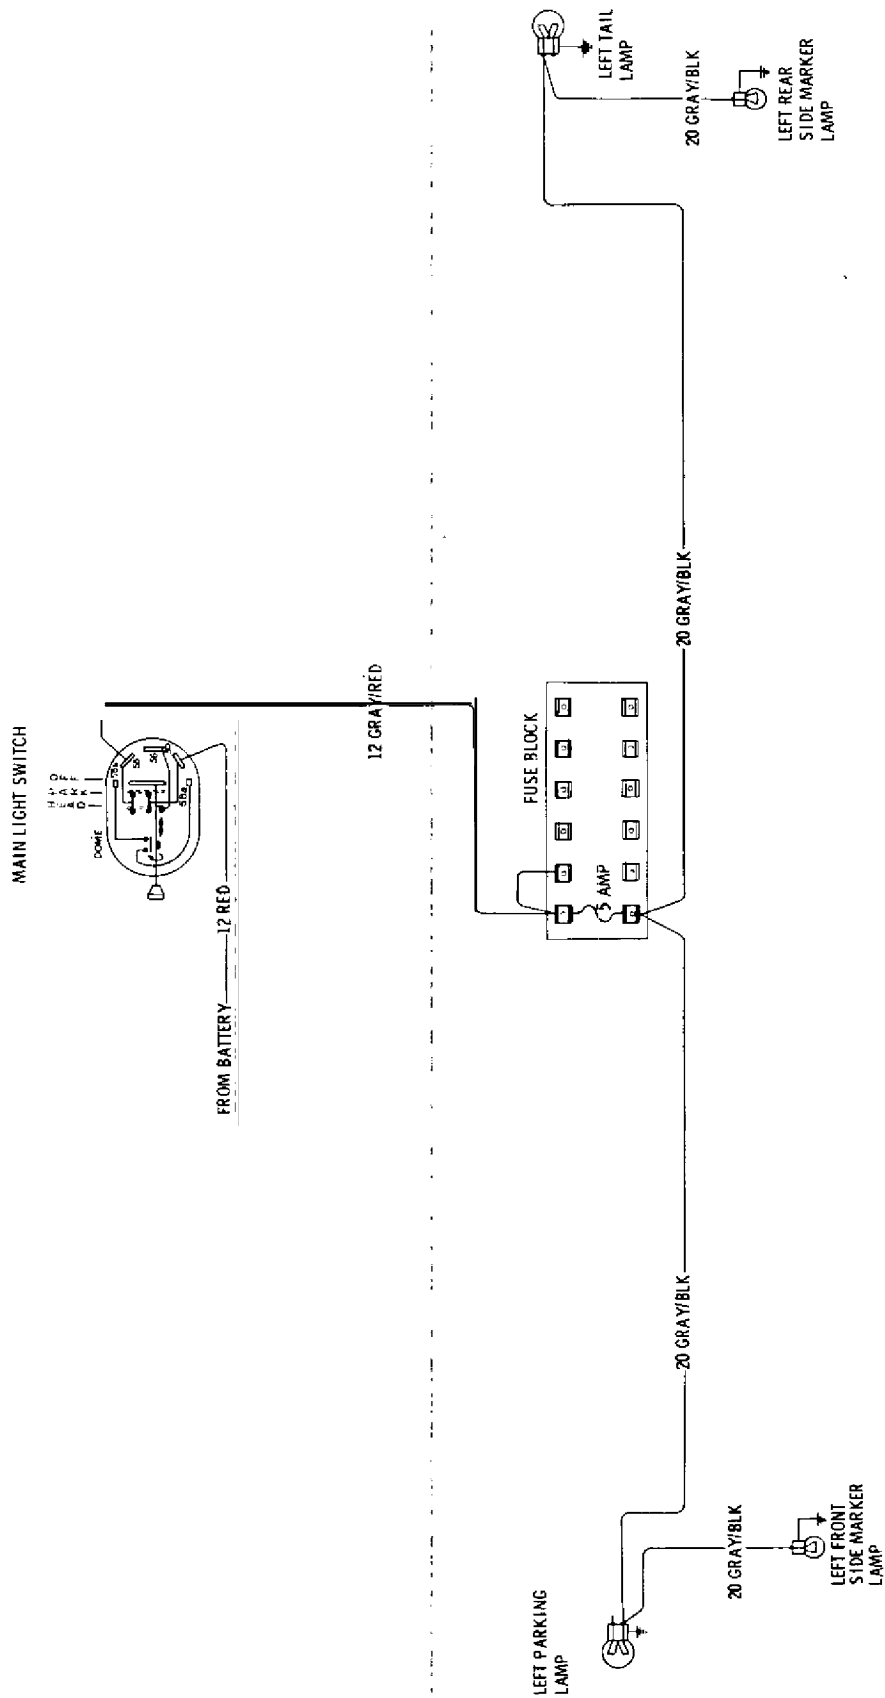
301J17

Figure 1J-17 Left Parking and Tail Lights - Opel 1900 - Manta

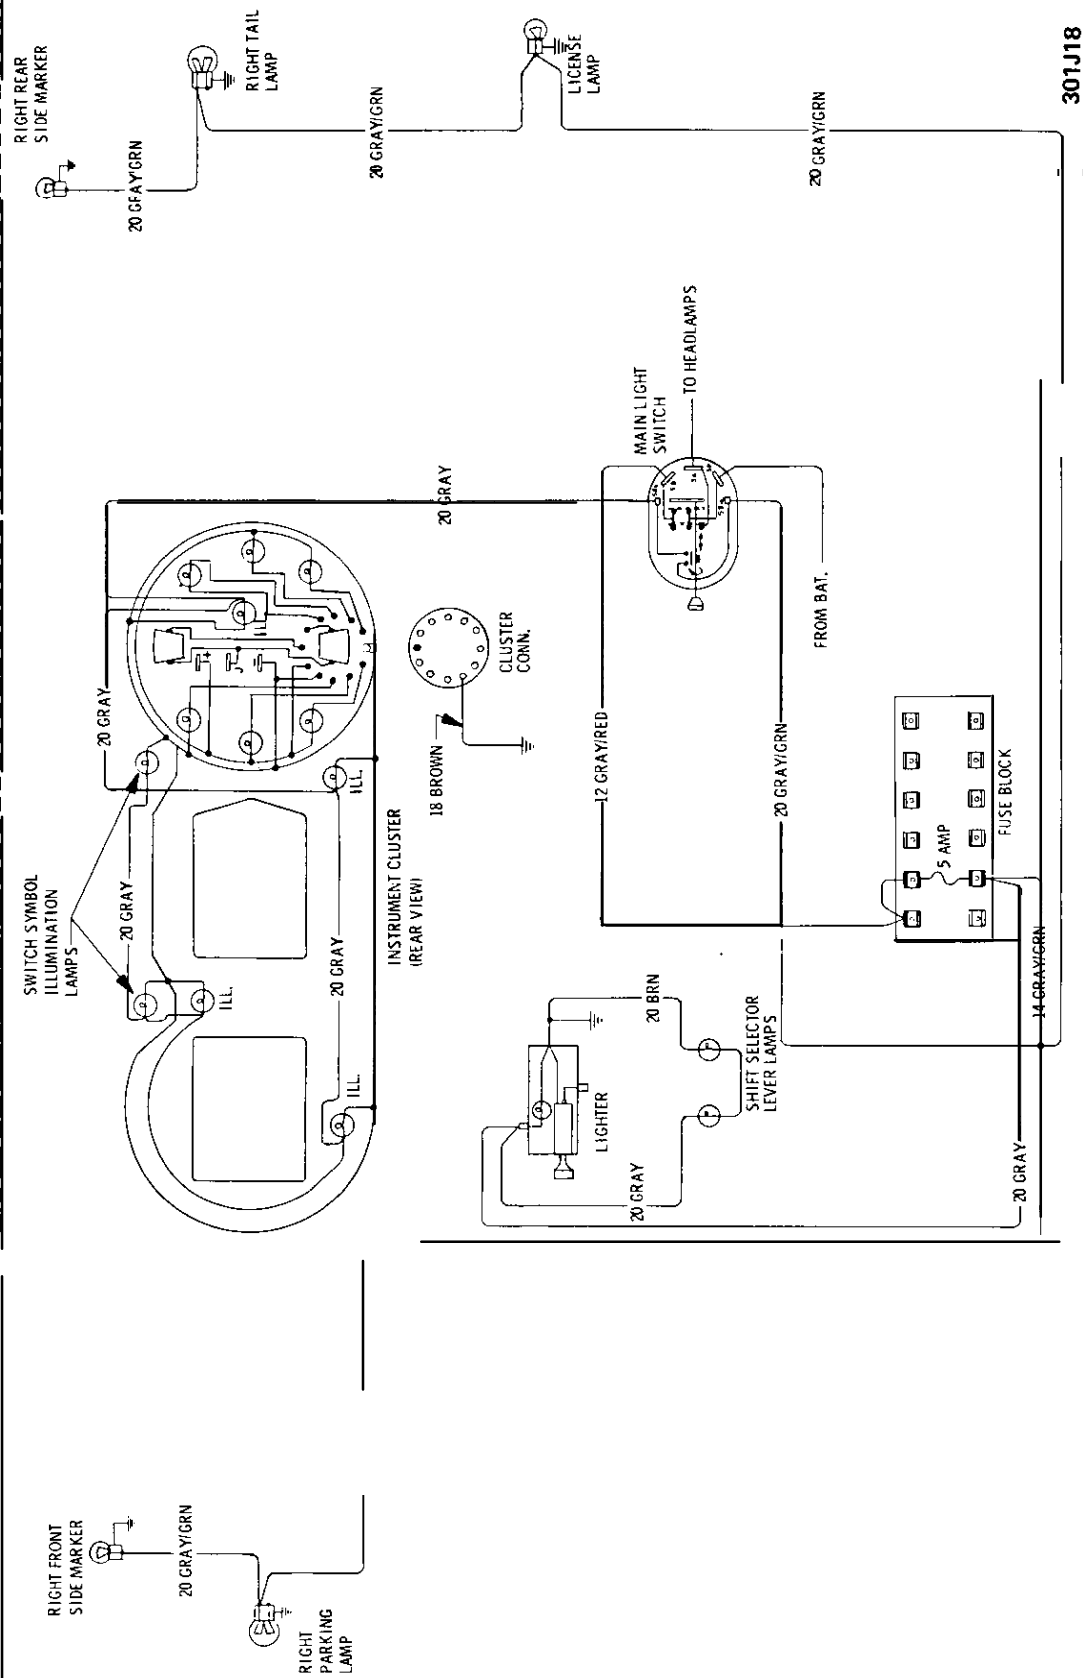
301J18

Figure 1J-18 Right Parking, Tail and Instrument Panel Lighting - Opel 1900 - Manta

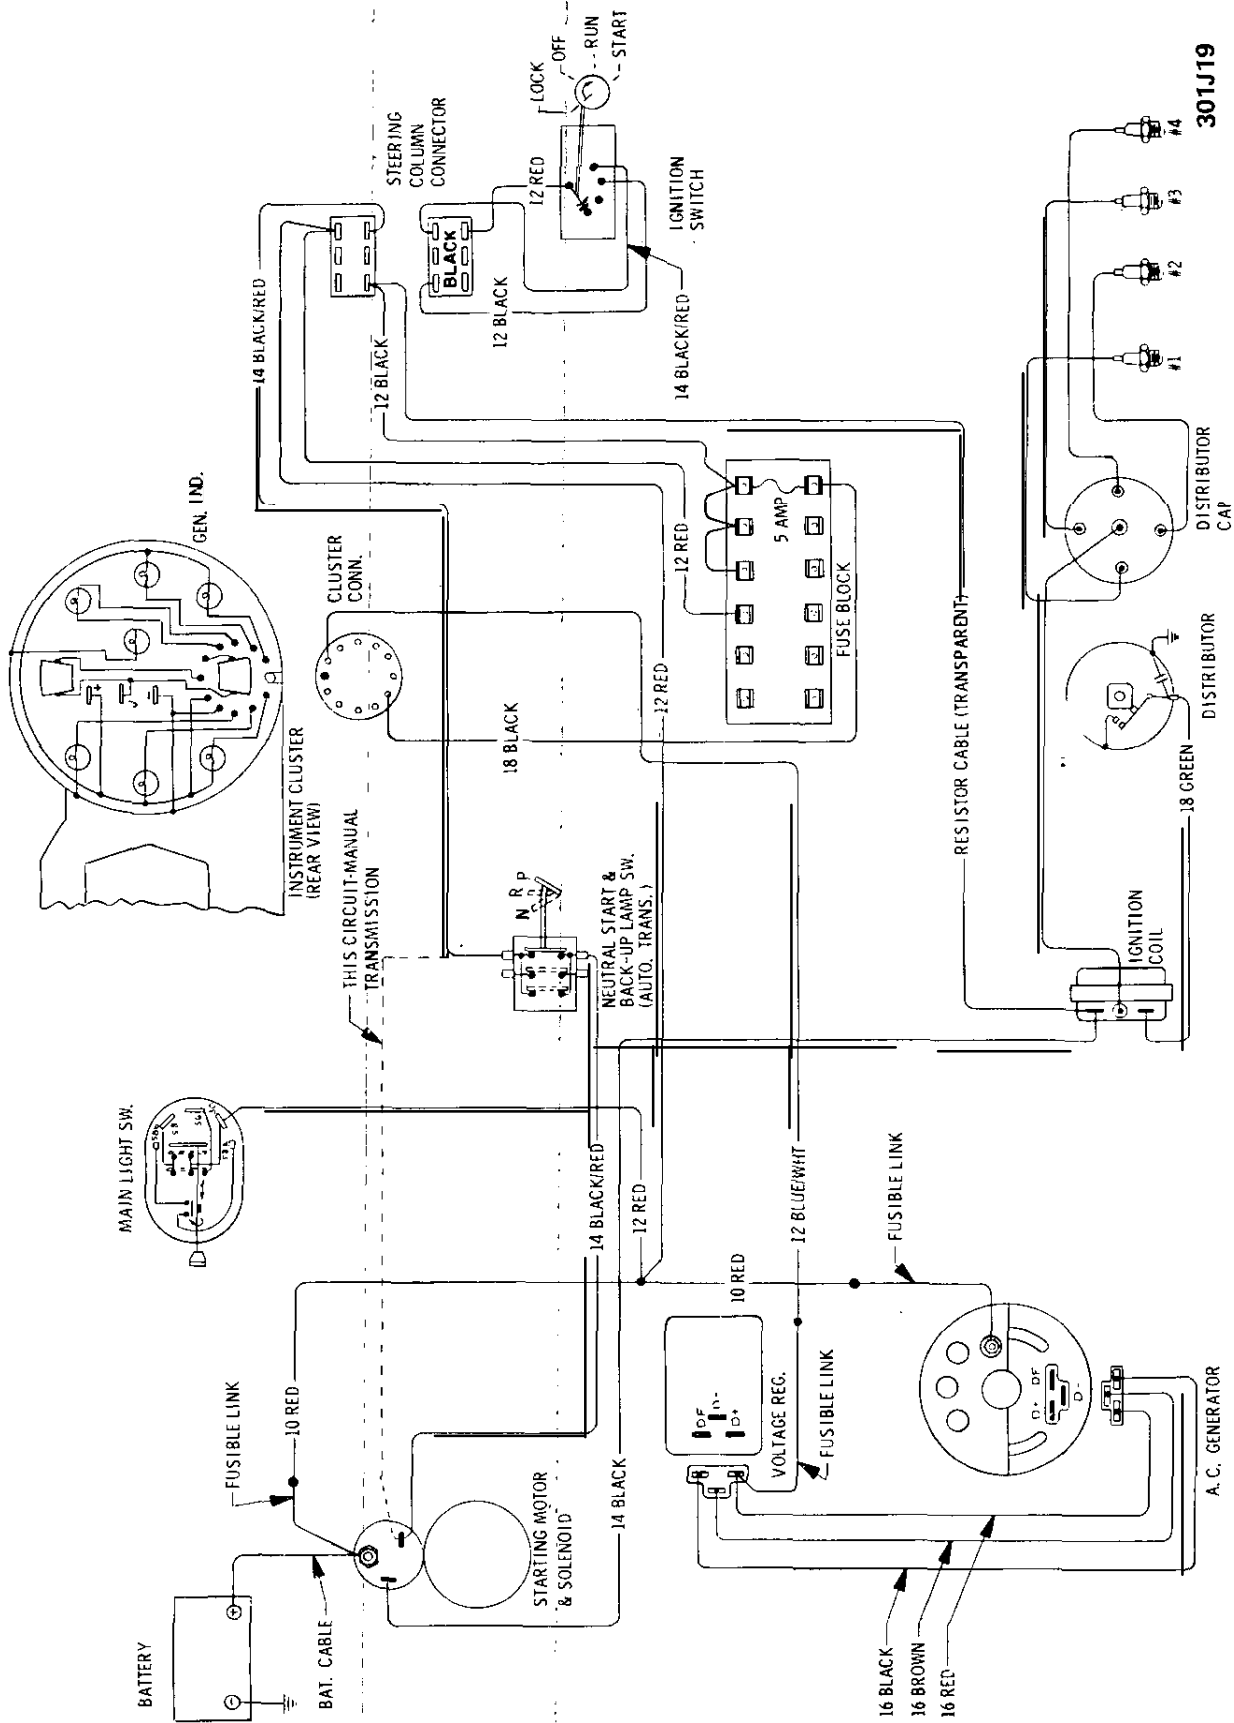
Figure 1J-19 Starting, Ignition and Charging Opel 1900 Manta

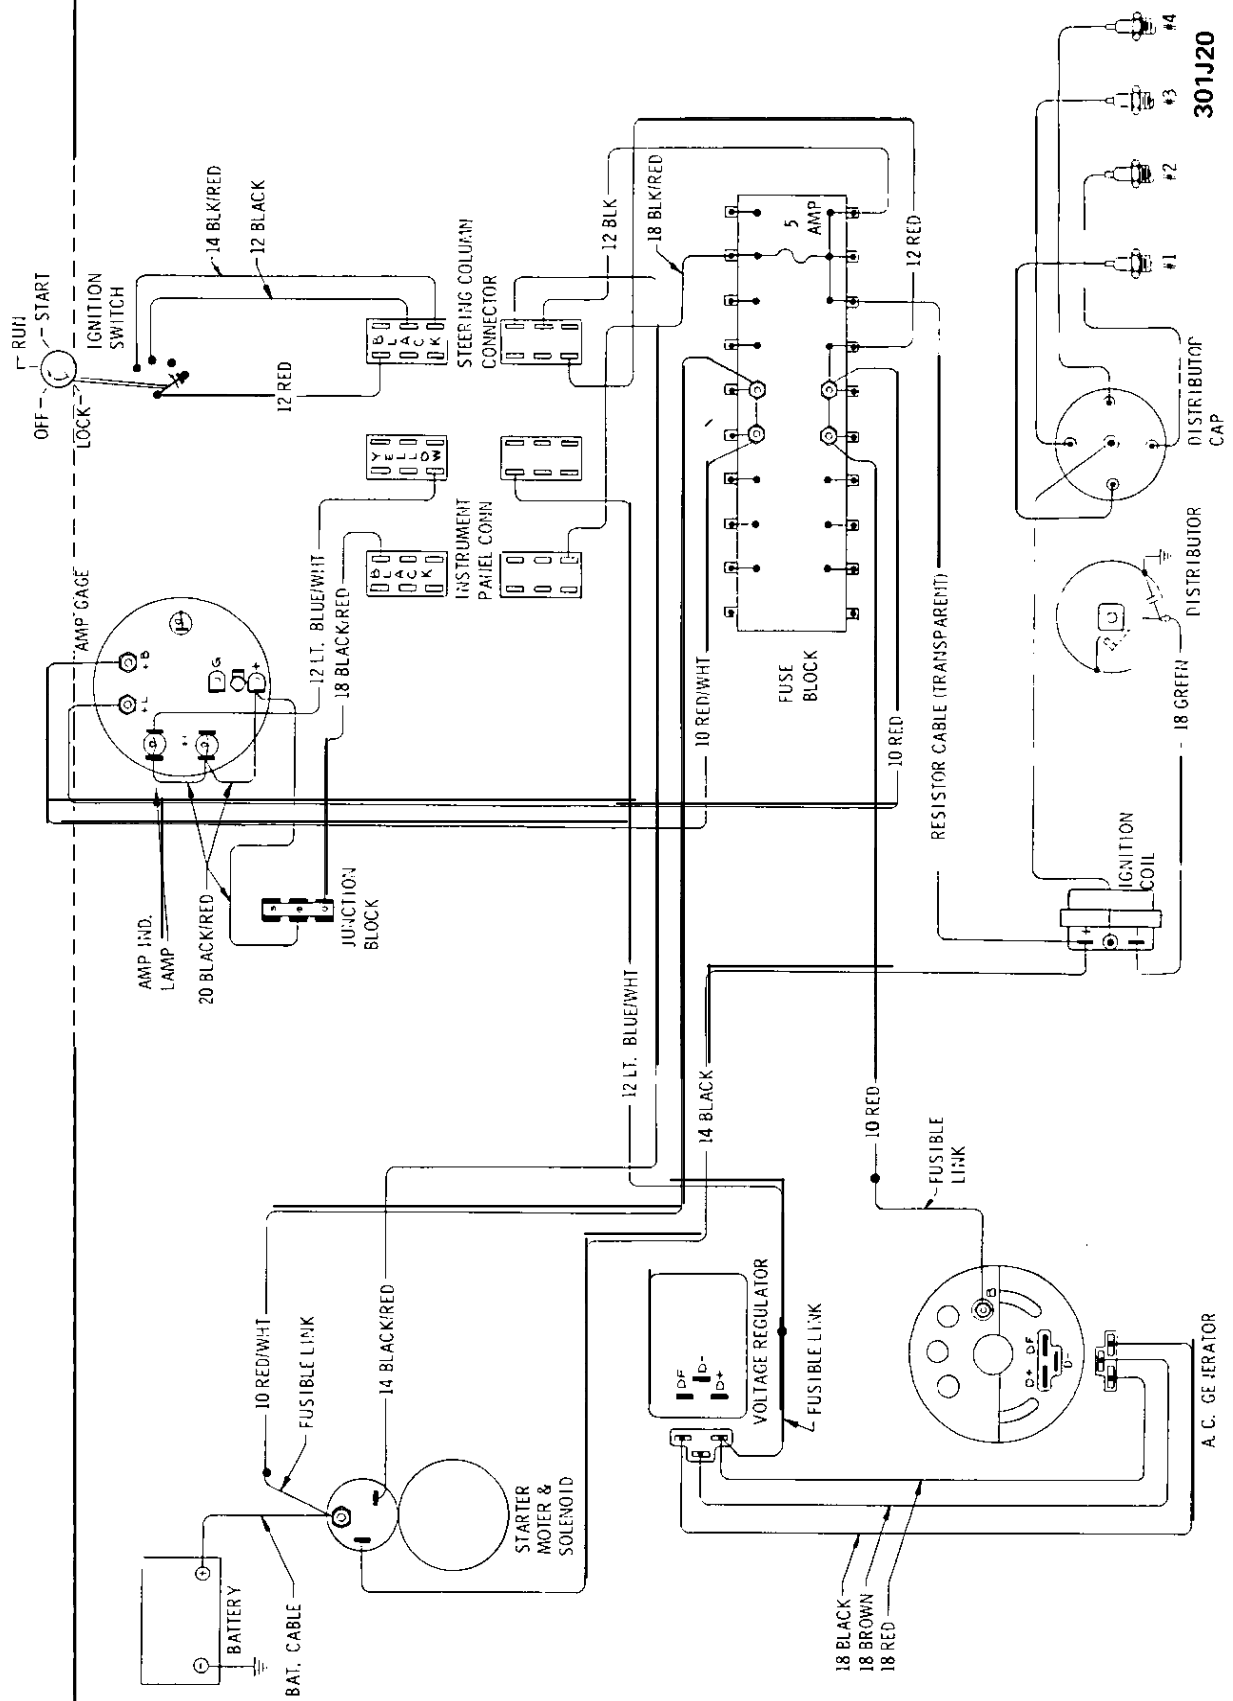
Figure 1J-20 Starting, Ignition and Charging GT

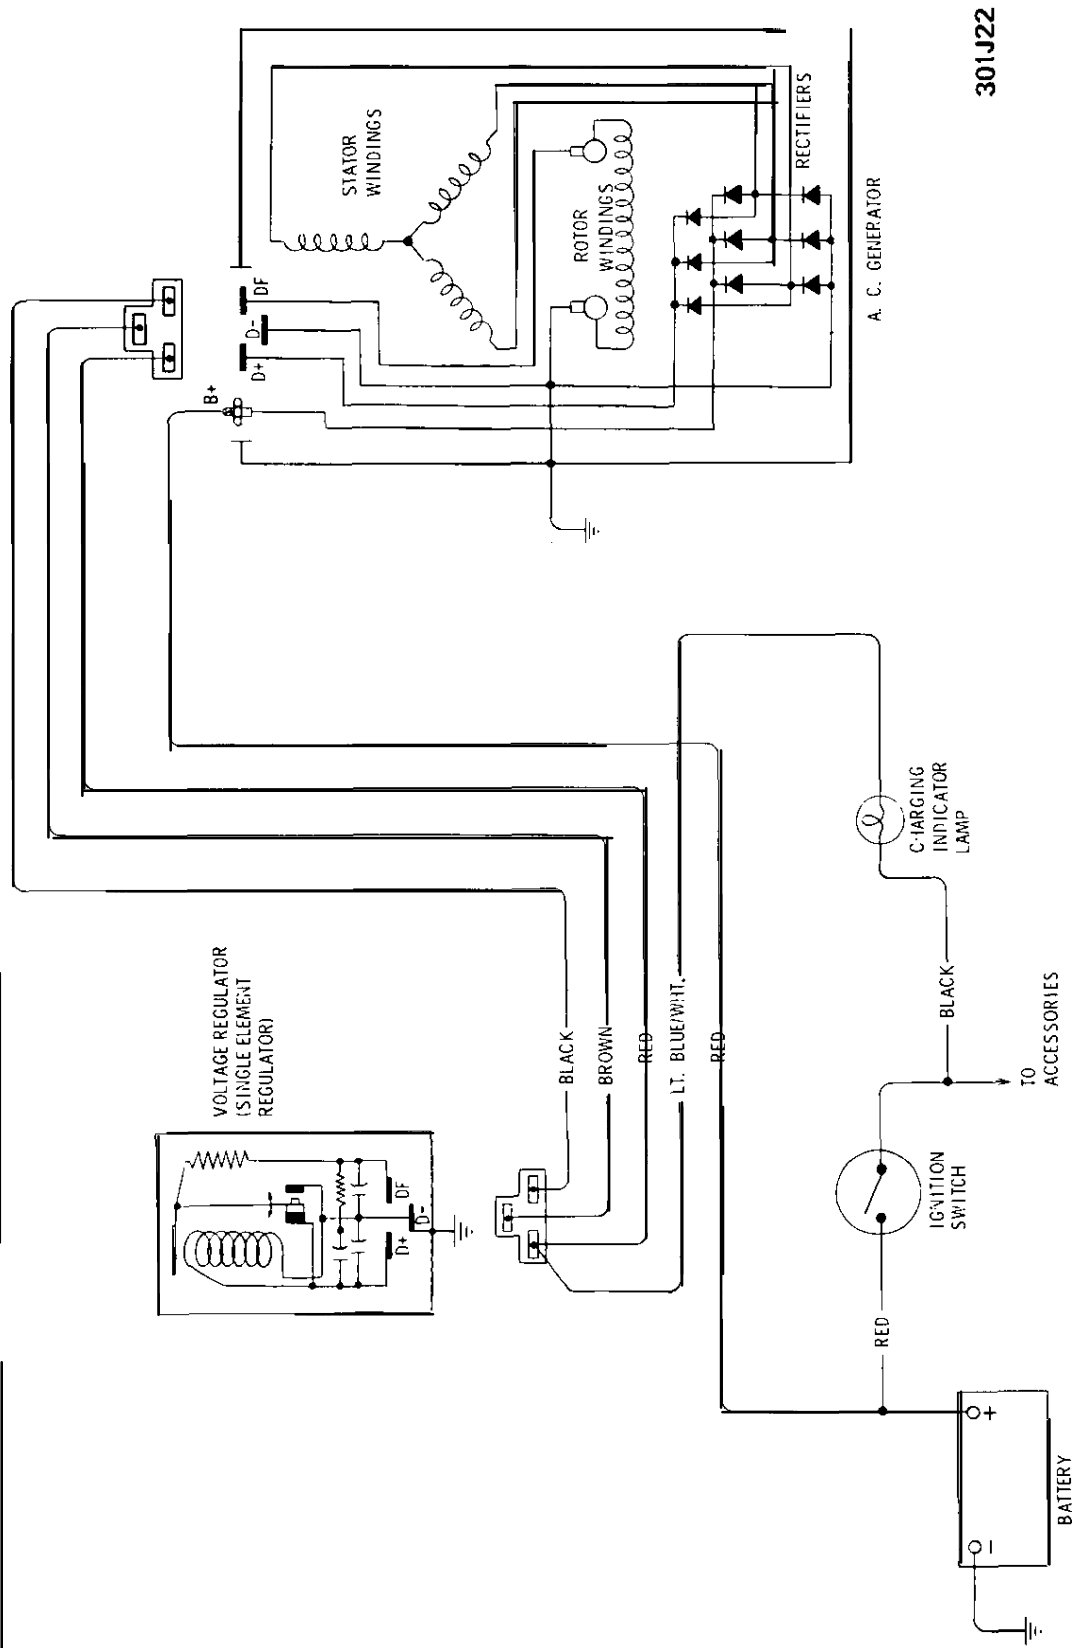
Figure 1J-22 A/C Generator and Regulator -All Models

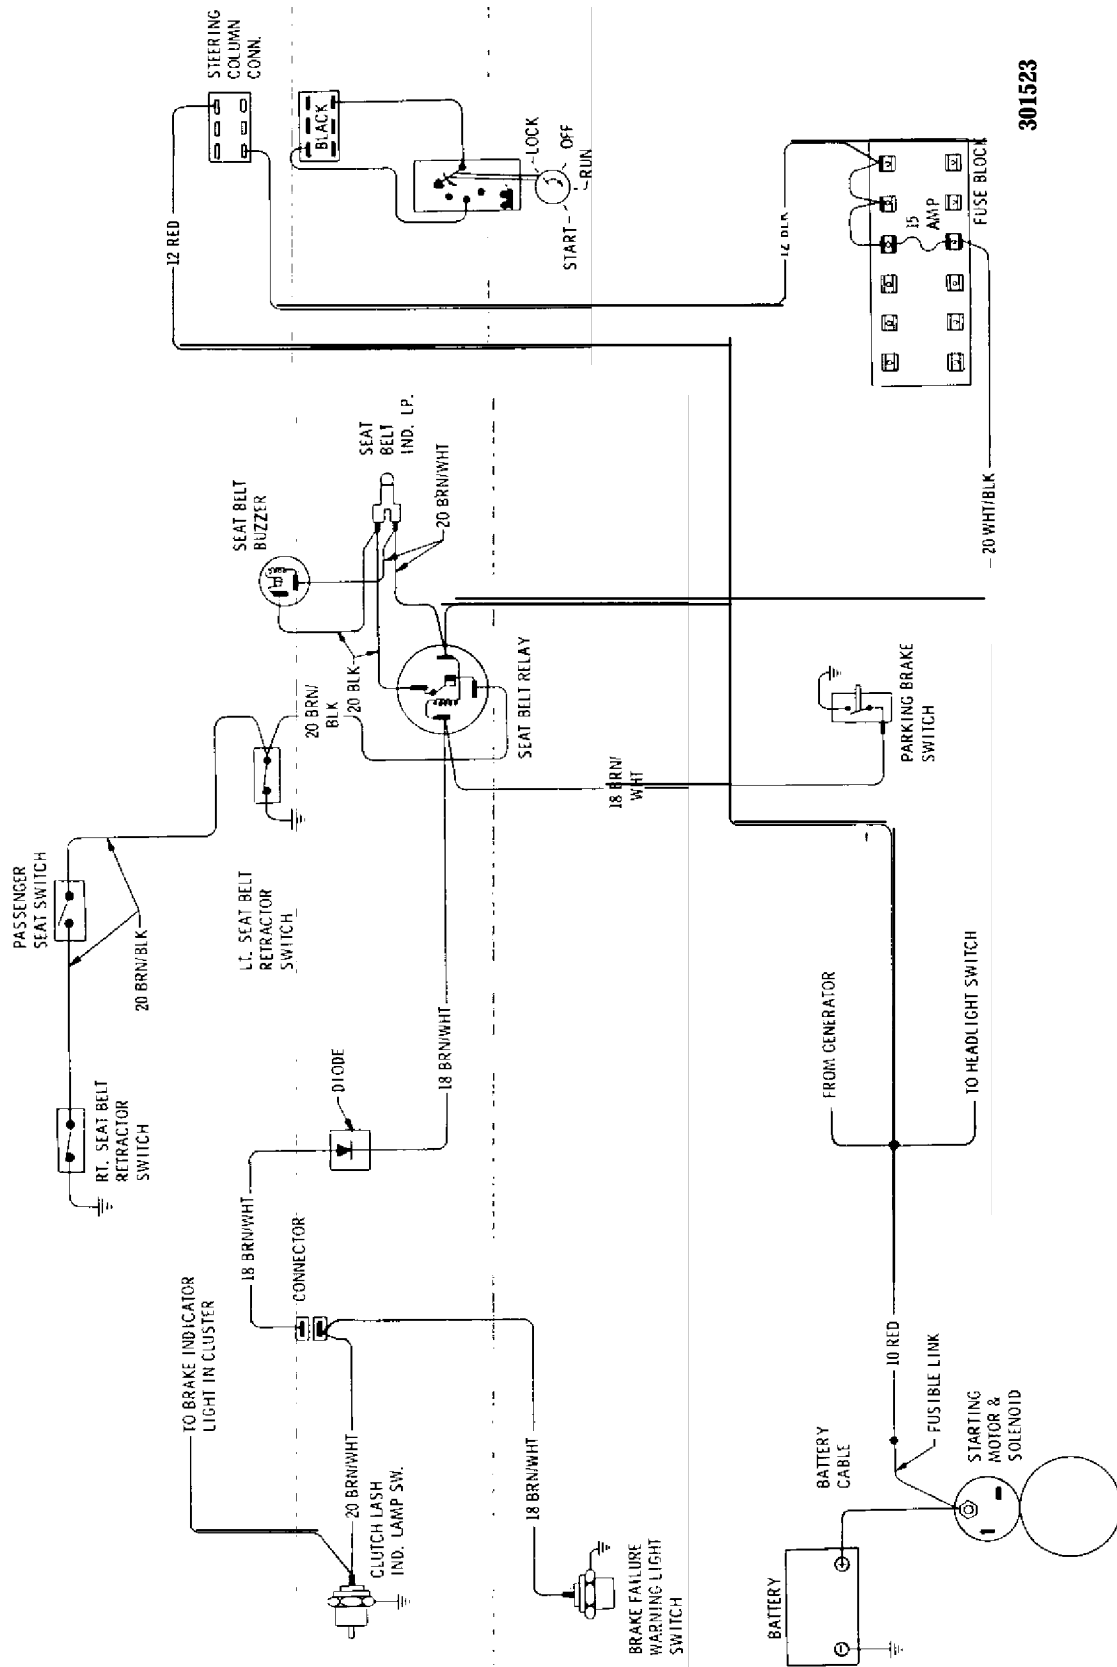
301523

Figure 1J-23 Seat Belt Warning System (Manual Transmission) Opel 1900 - Manta

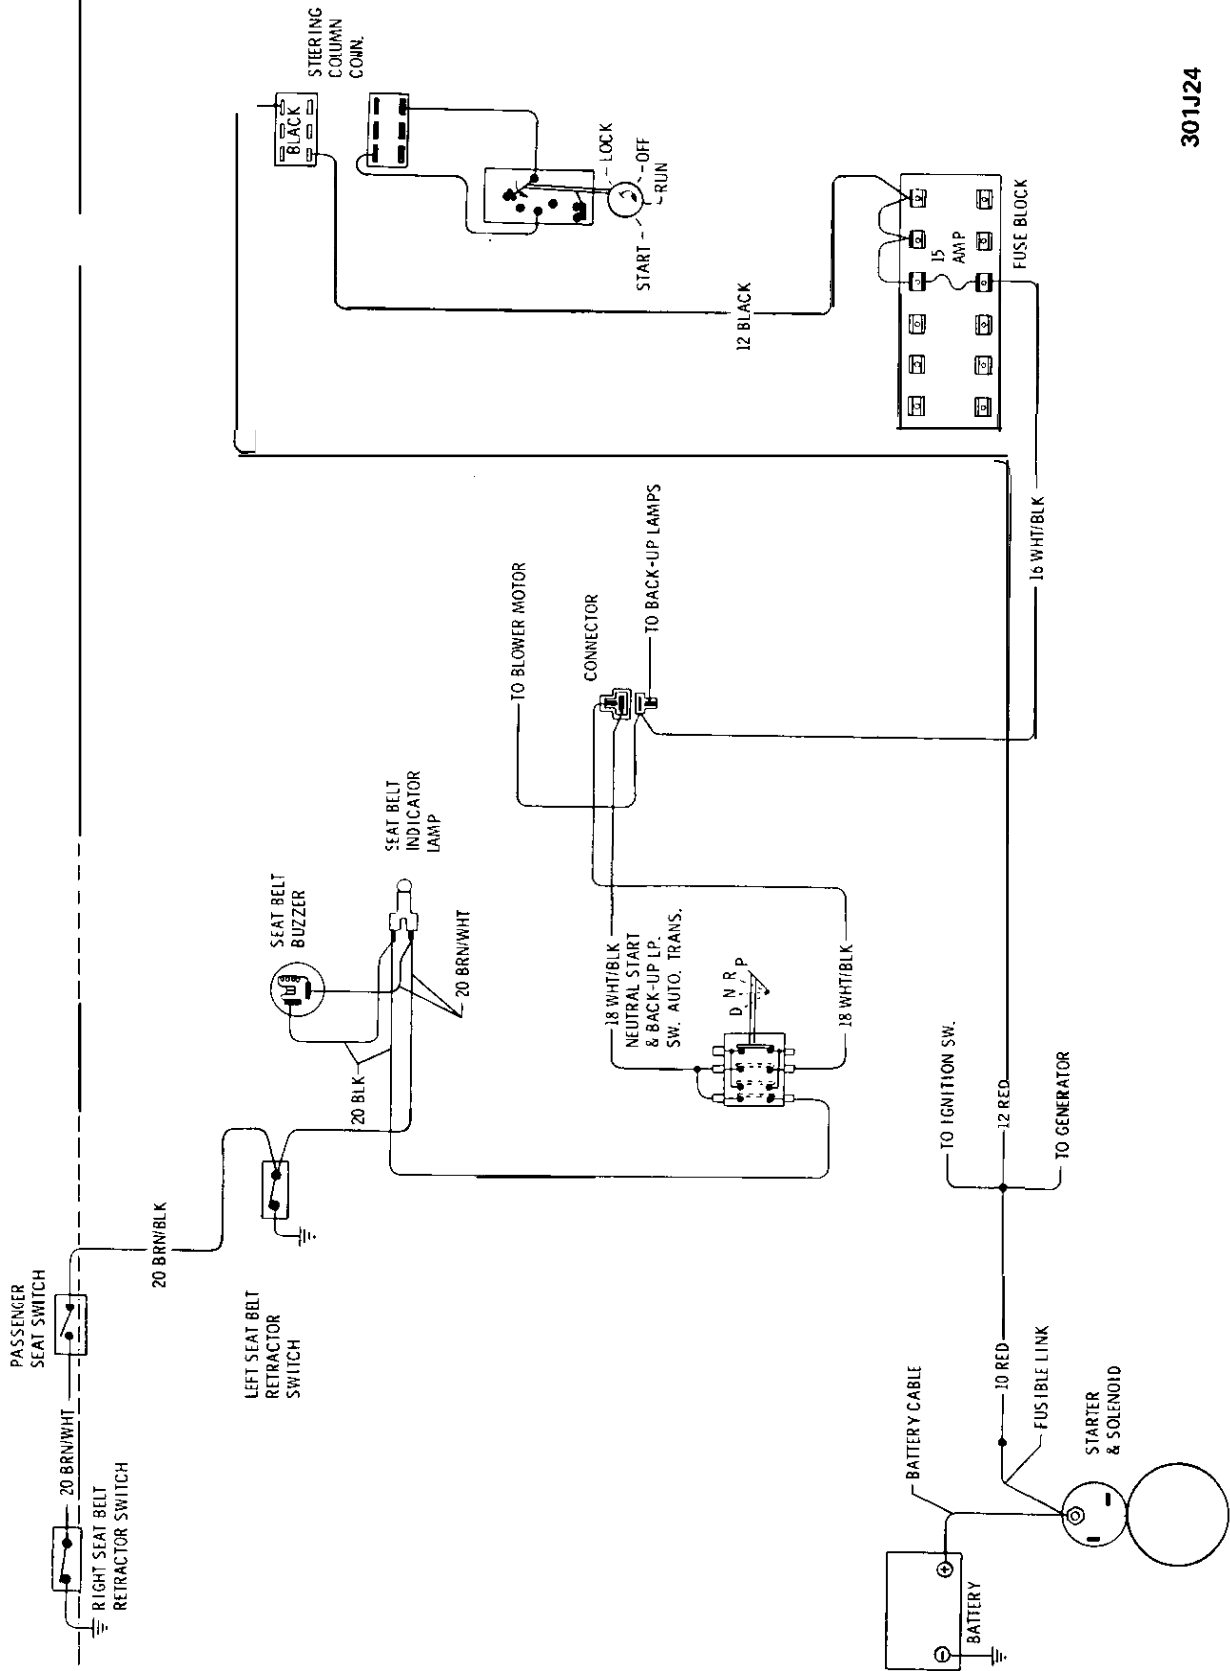
301J24

Figure 1 J-24 Seat Belt Warning System (Automatic Transmission) Opel 1900 Manta

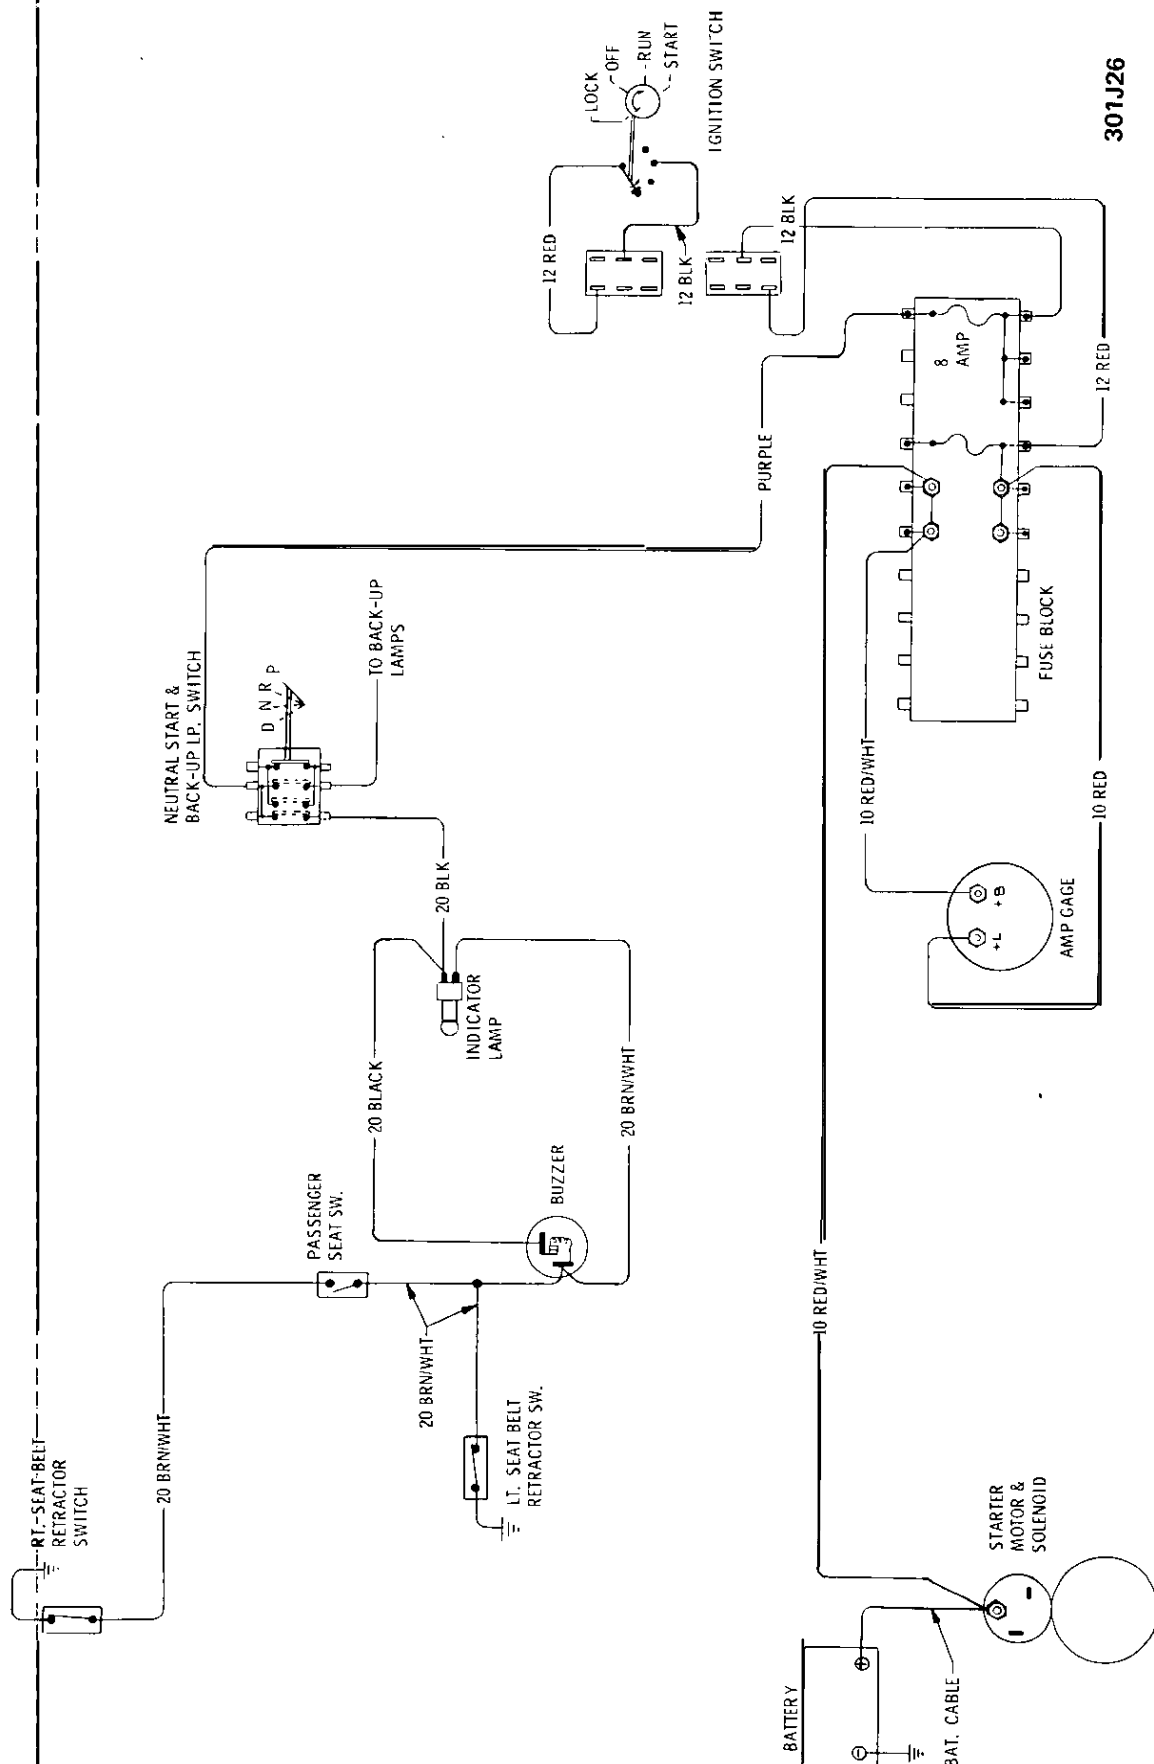
301J26

Figure 1J-26 Seat Belt Warning System (Automatic Transmission) • GT

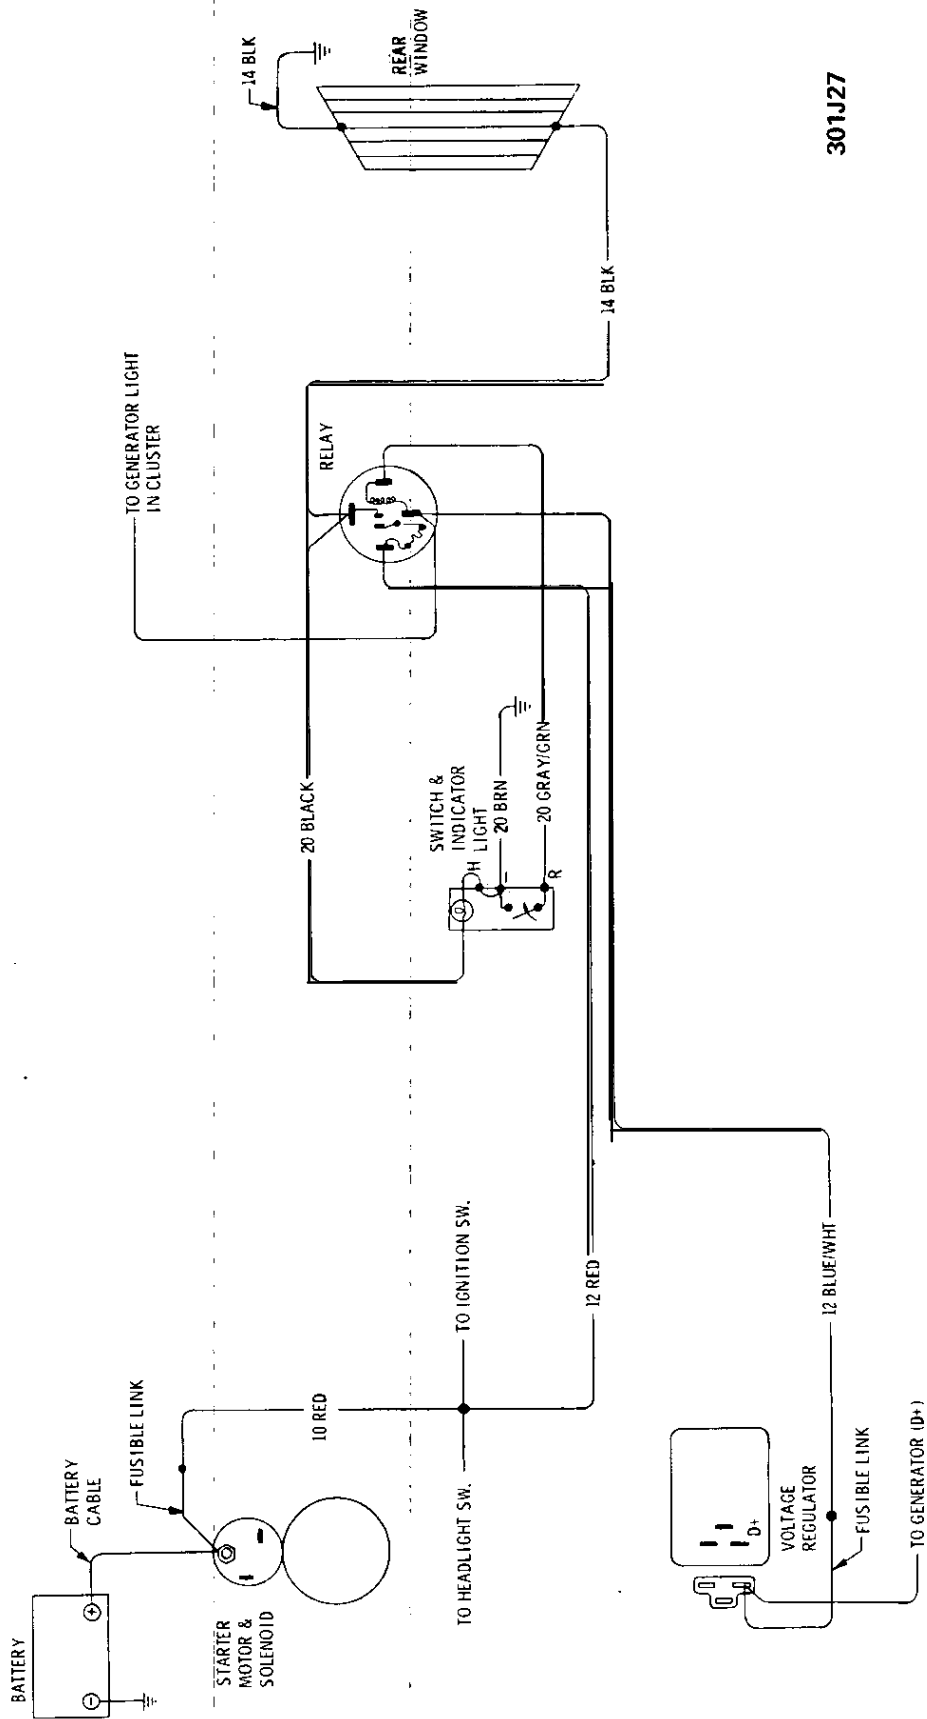
301J27

Figure 1 J-27 Heated Rear Glass · Opel 1900 · Manta

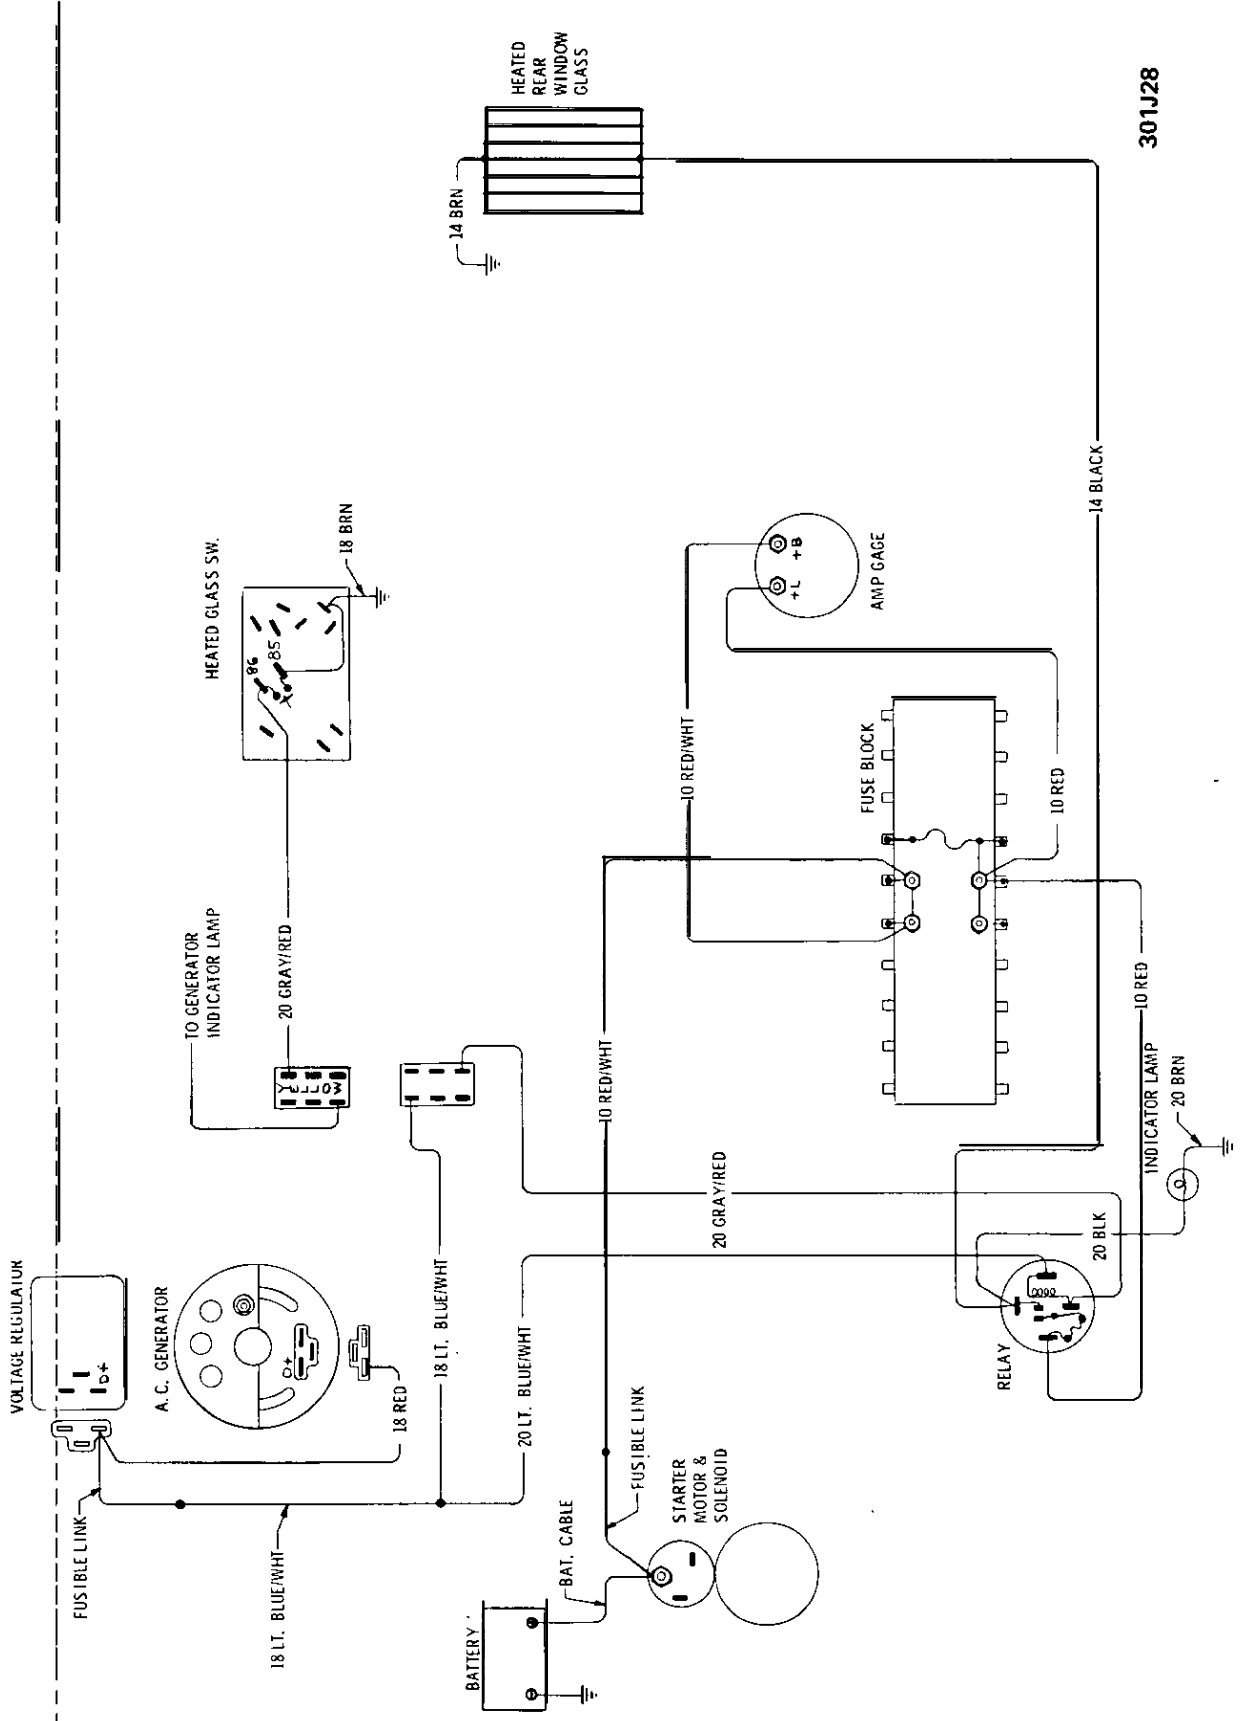
301J28

Figure 1J-28 Heated Rear Glass - GT
